Debris Flow Mitigation at the East Gate Landslide

Glacier National Park

January 1997 reactivation
of ancient landslide –
2,000,000m³ failure

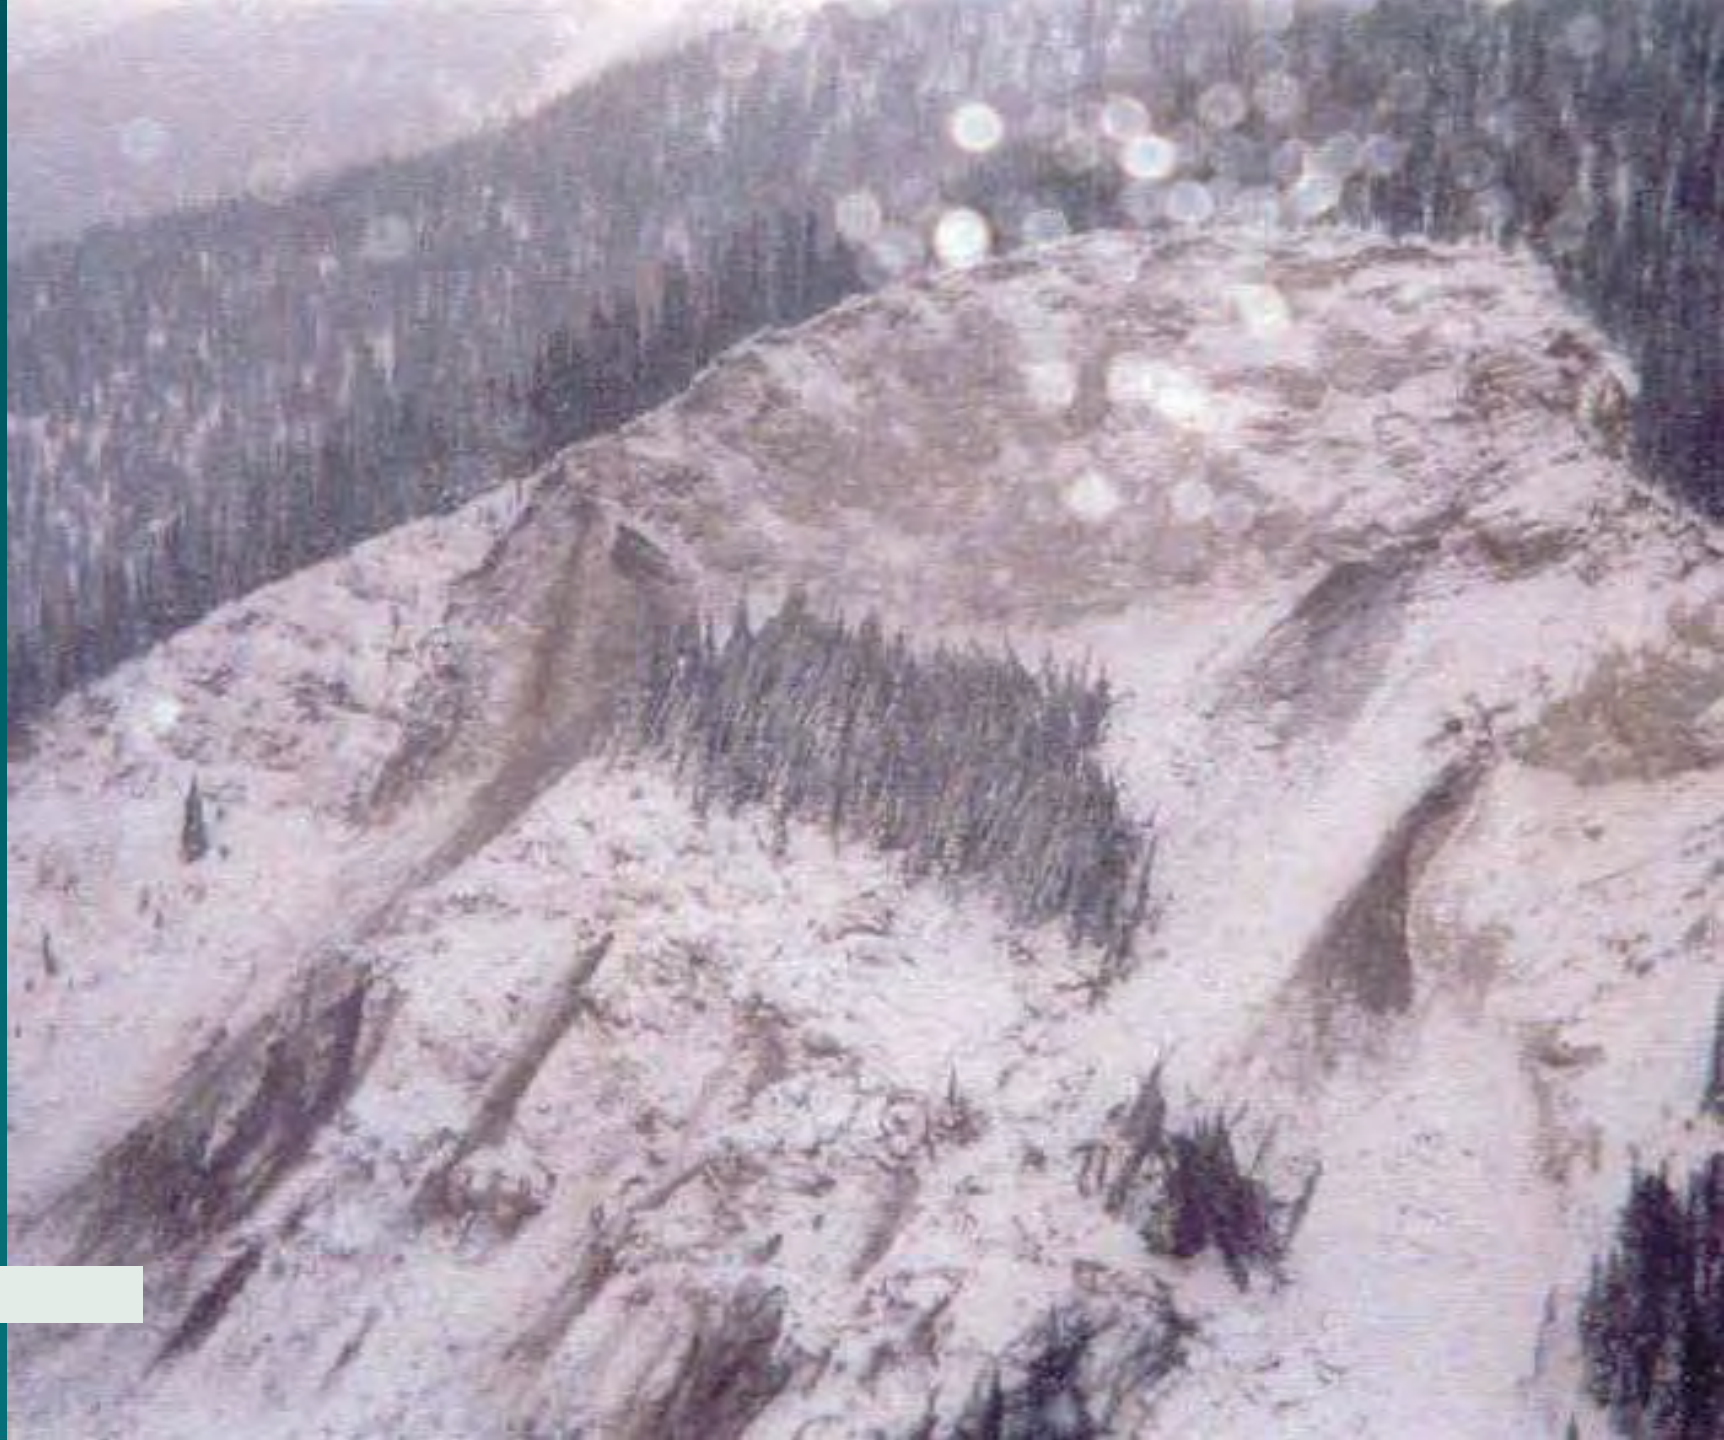
Photo by PCA, January 1997

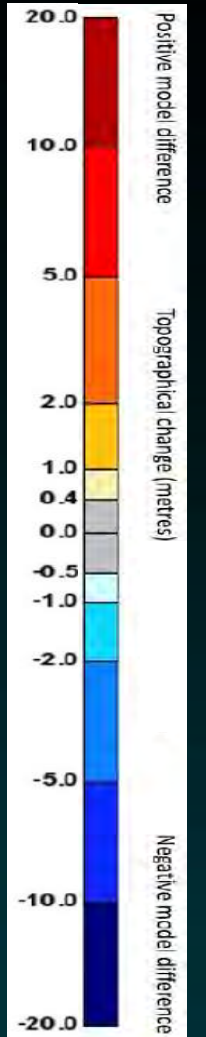
Gully Evolution: 2015 LiDAR vs. 2018 LiDAR

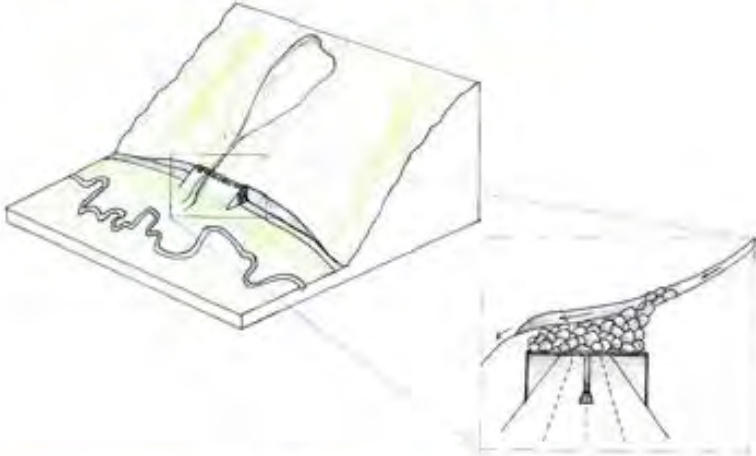
Cut and Cover Tunnel

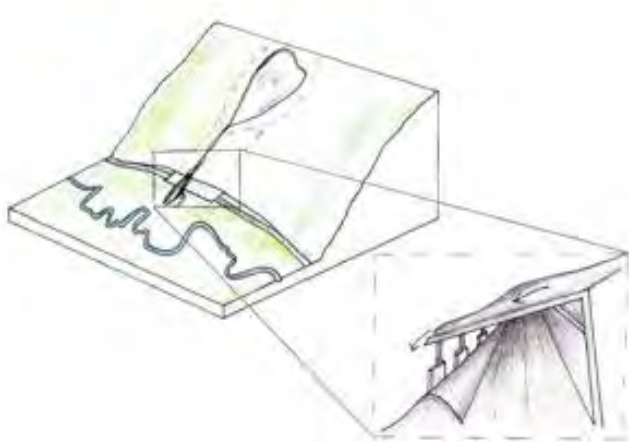
Shed Structure

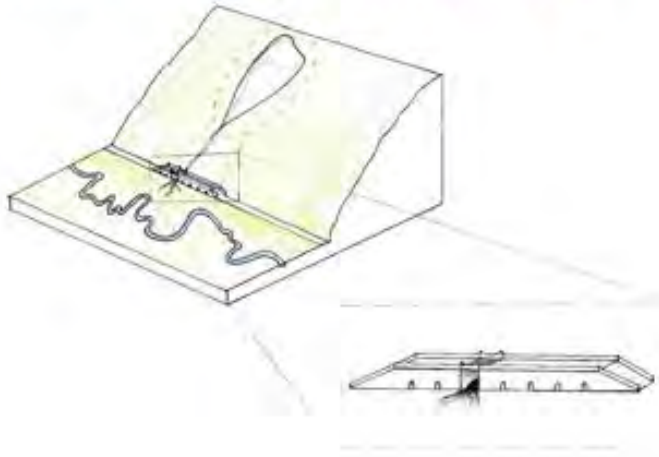
Berm-to-Bridge Structure

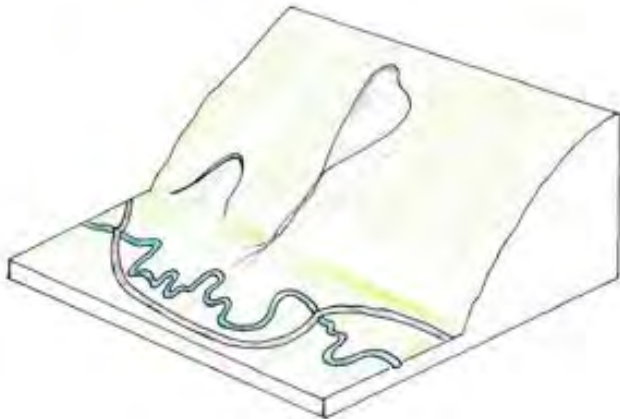
Highway Realignment

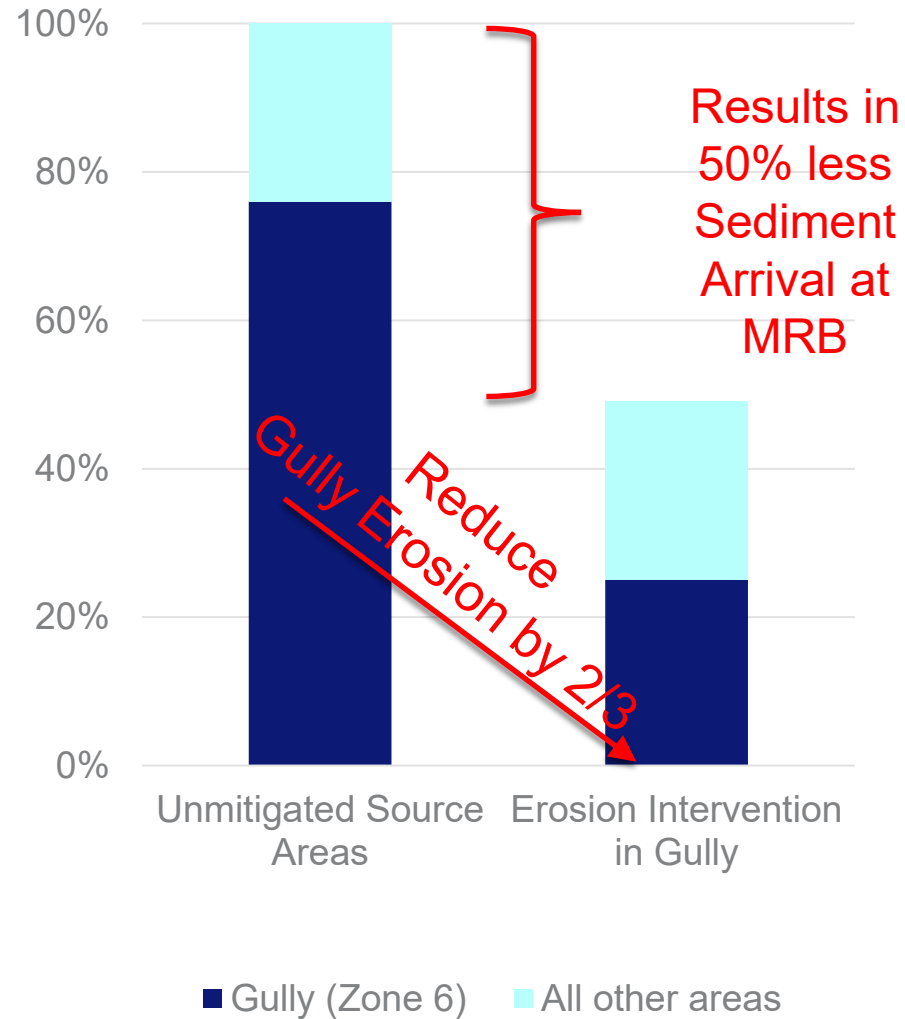
Sediment Arrival at Berm Apex

- $\frac{3}{4}$ of debris is mobilized from Main Gully
- Recommended feasibility assessment of gully erosion intervention strategies:
 - Check dams
 - Water diversion
 - Revegetation

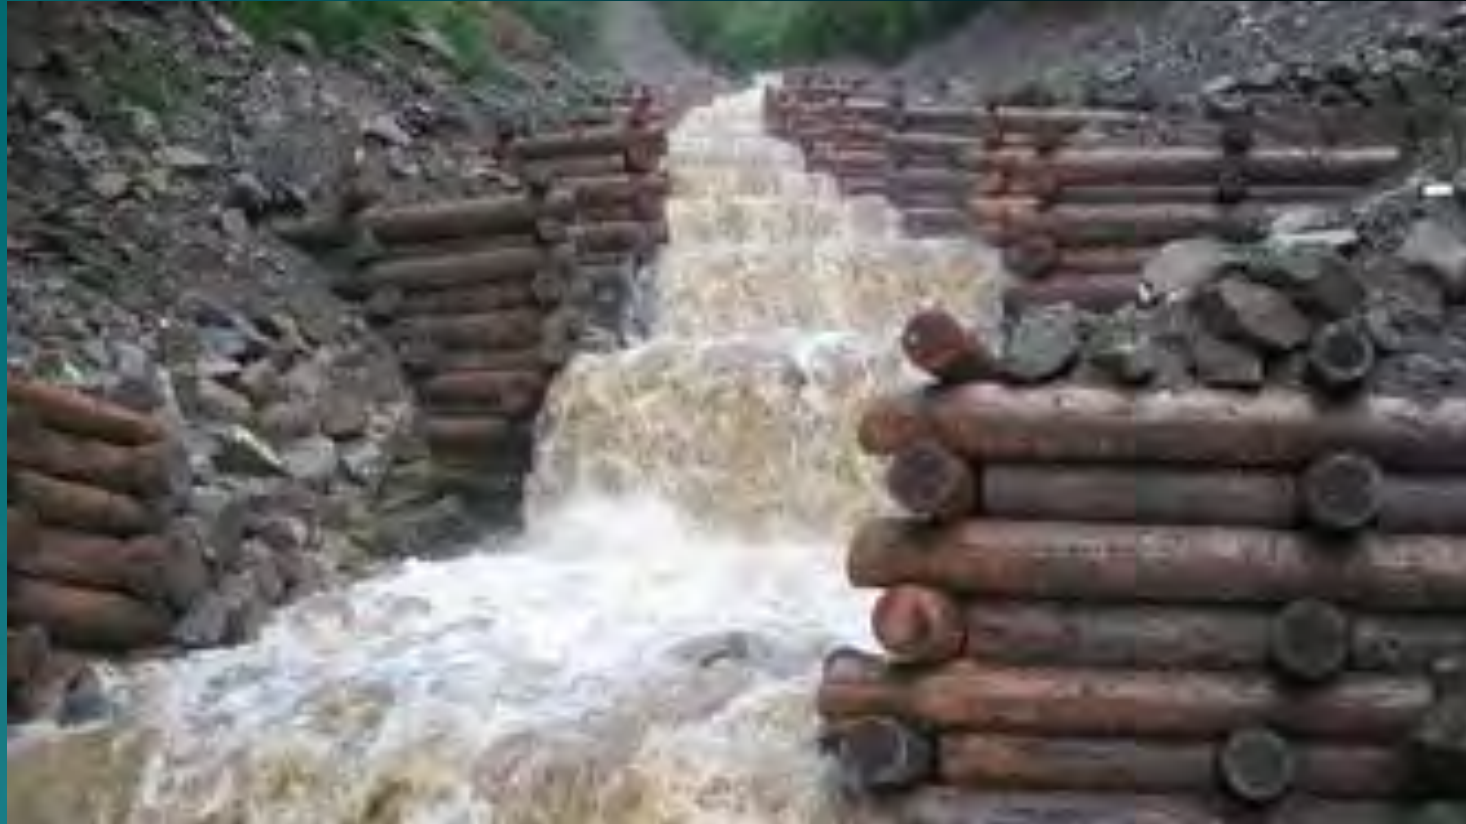
Check Dams

- Grade control -> Stops vertical incision
- Debris flow discharge is key parameter for sizing check dam weirs and defines height of wingwalls to prevent outflanking

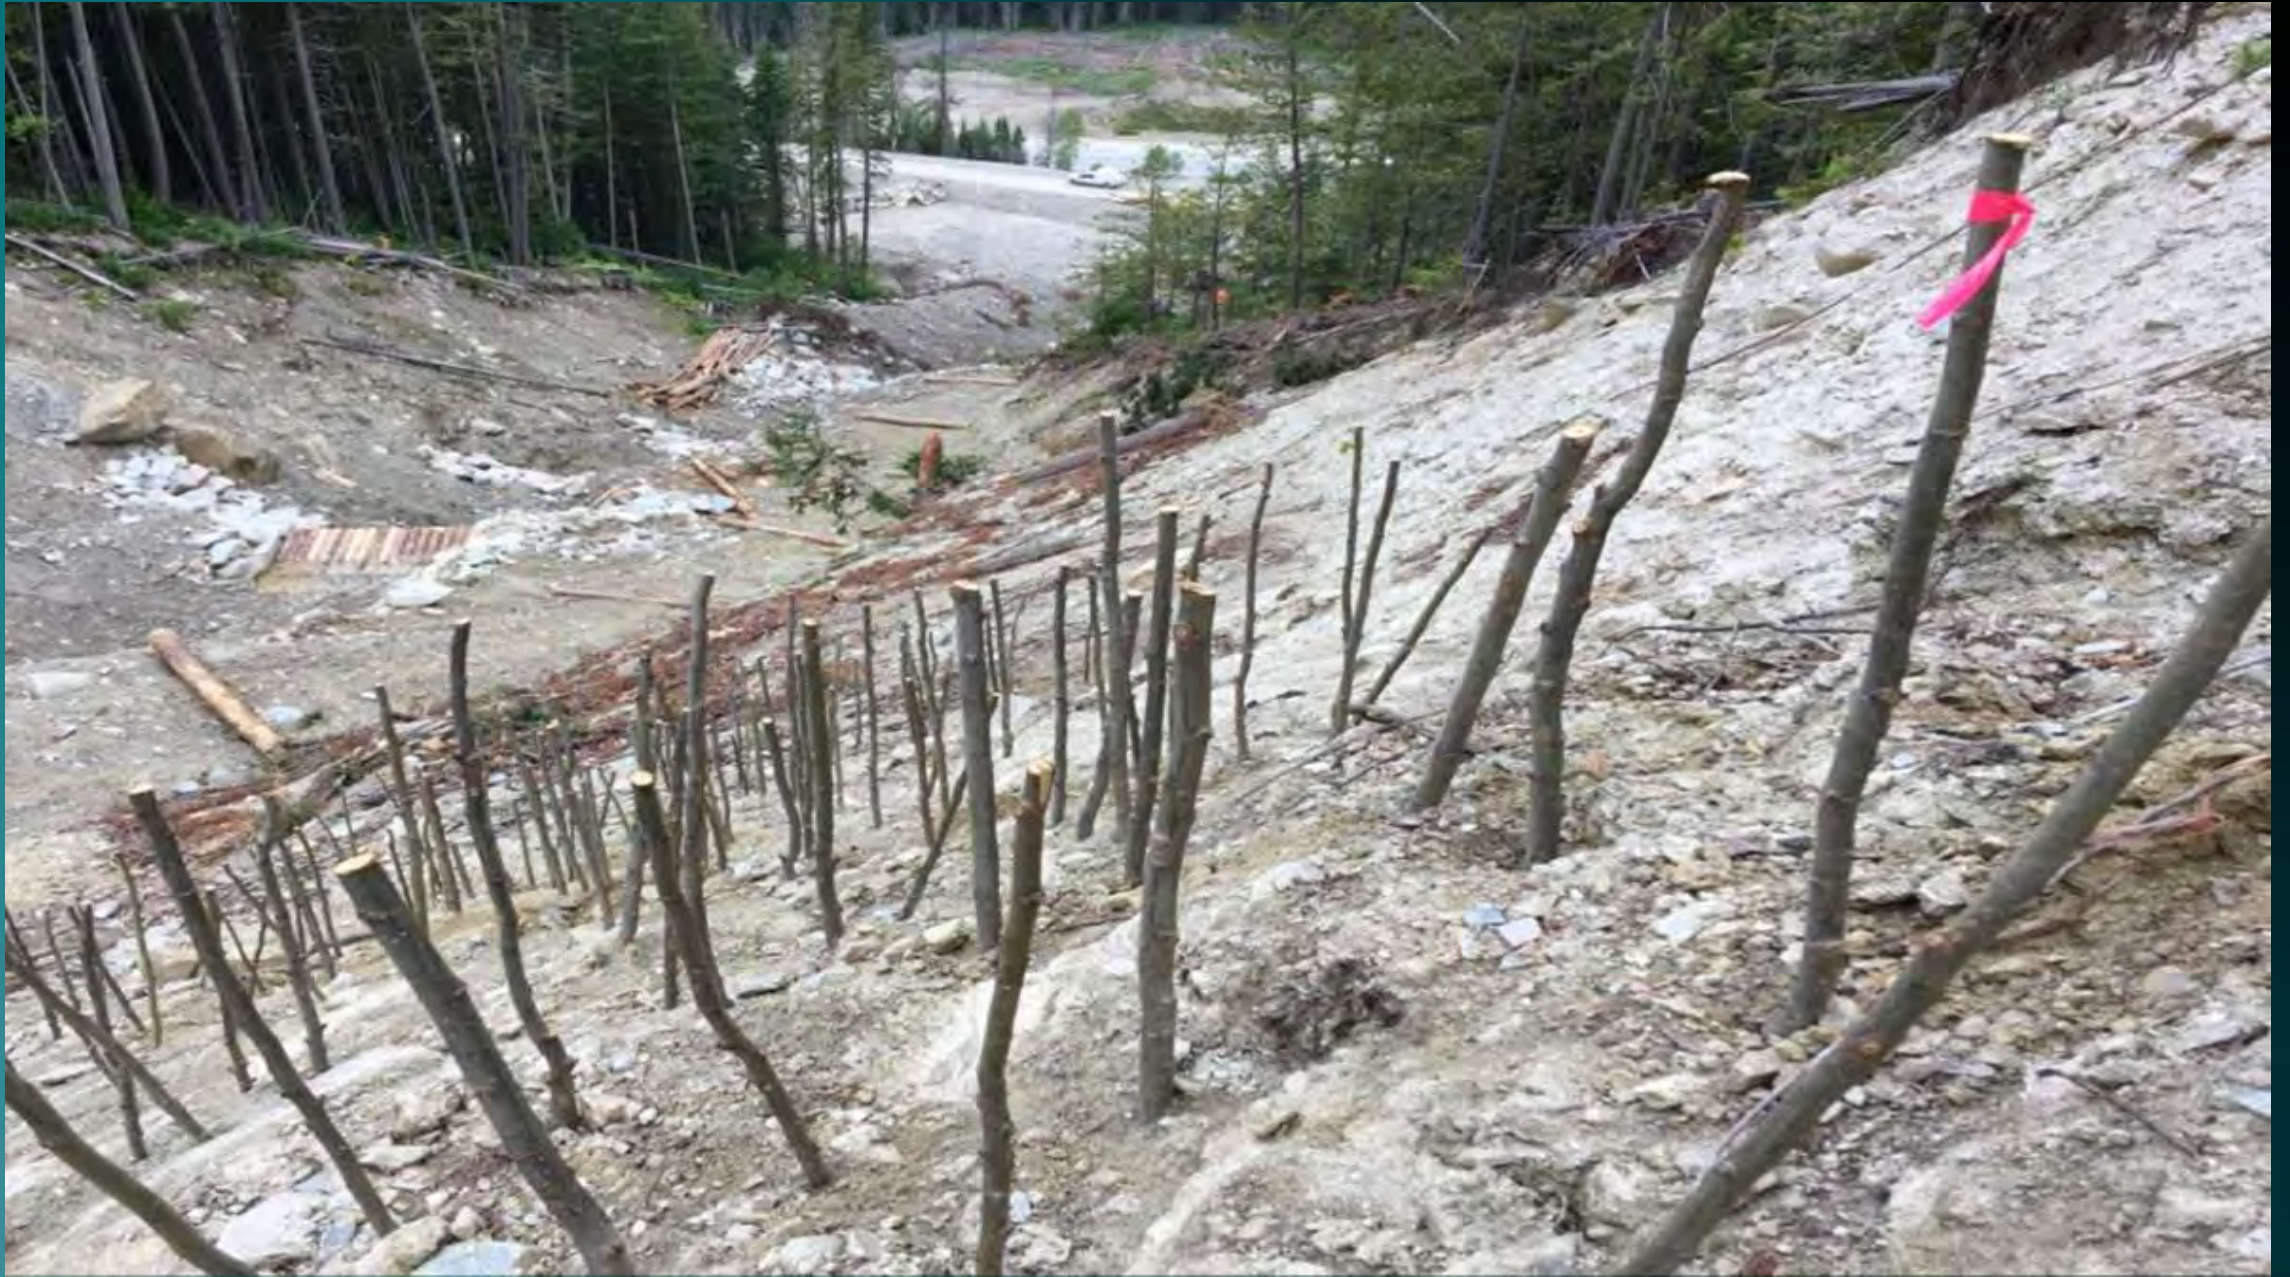
Live Staking

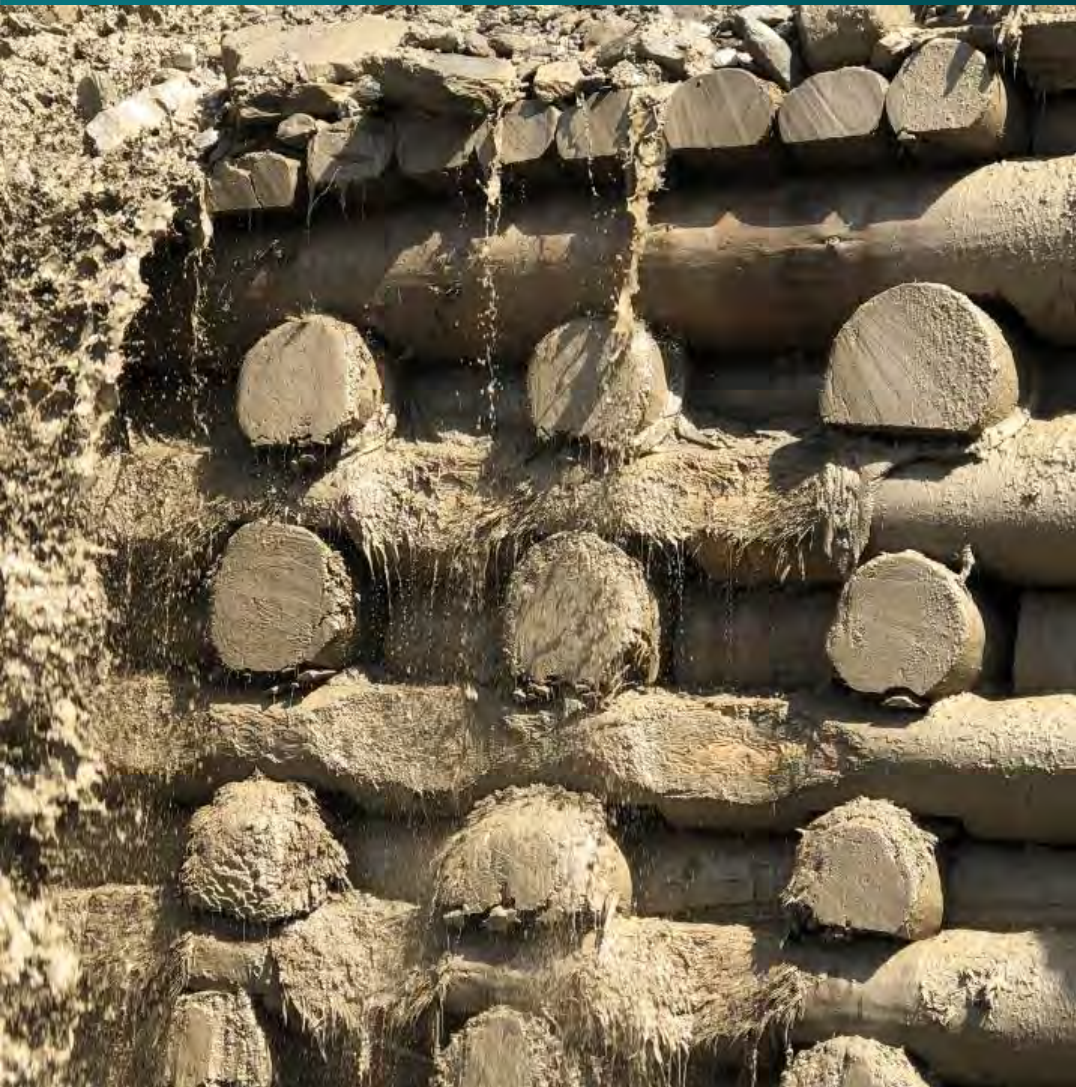
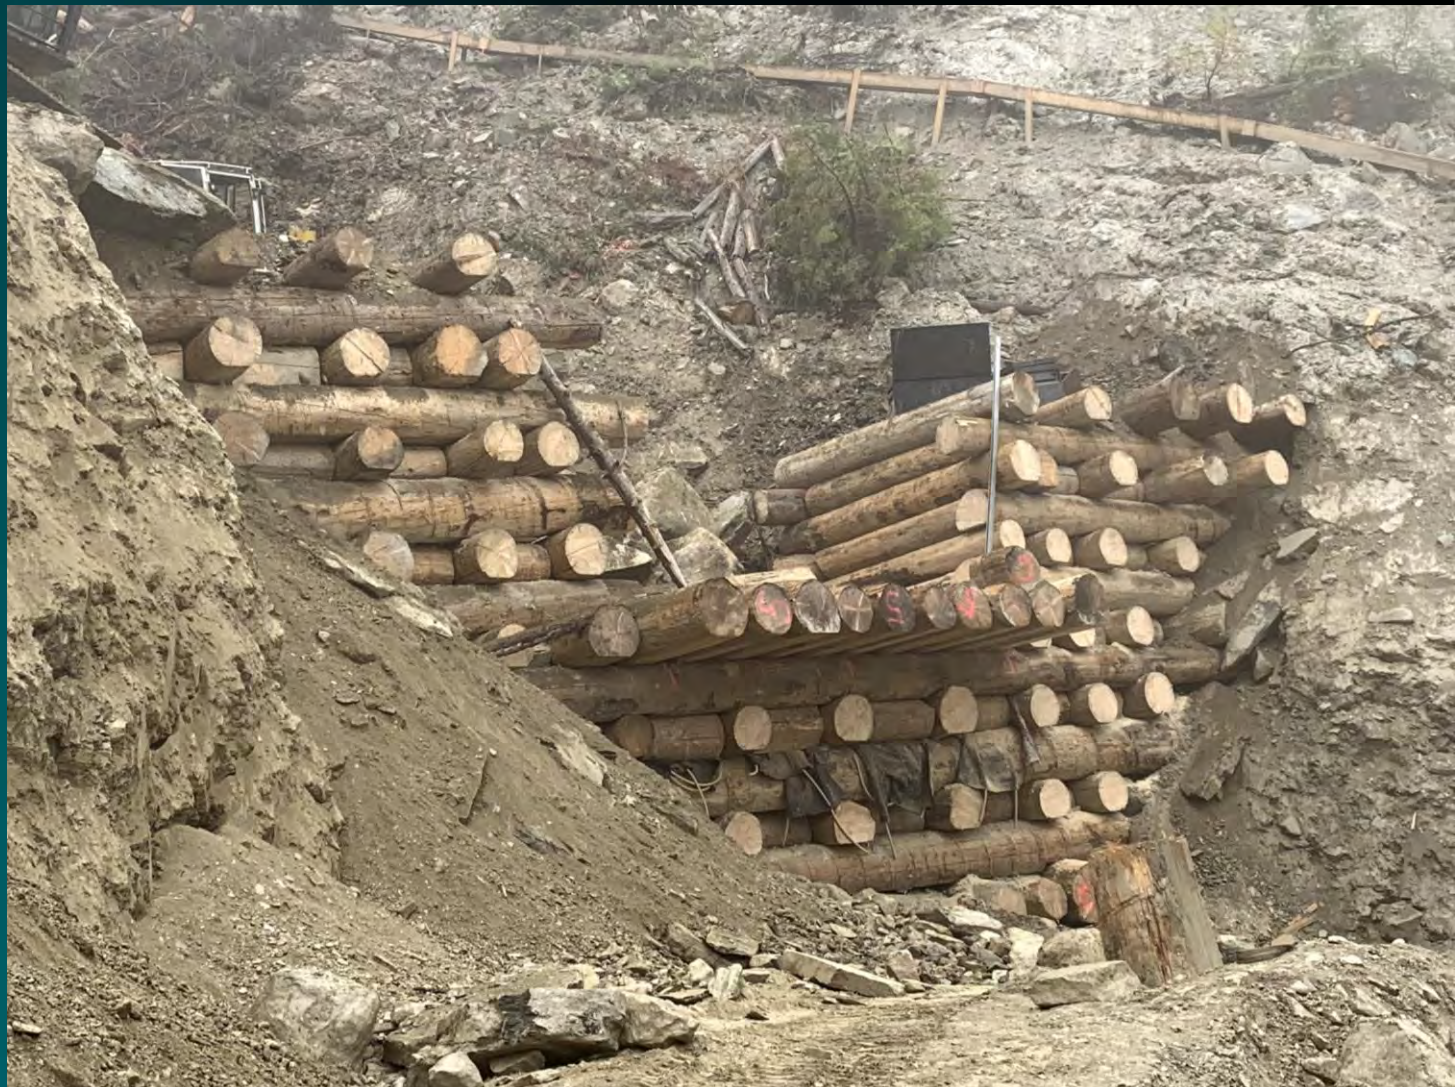
Front Face Abrasion

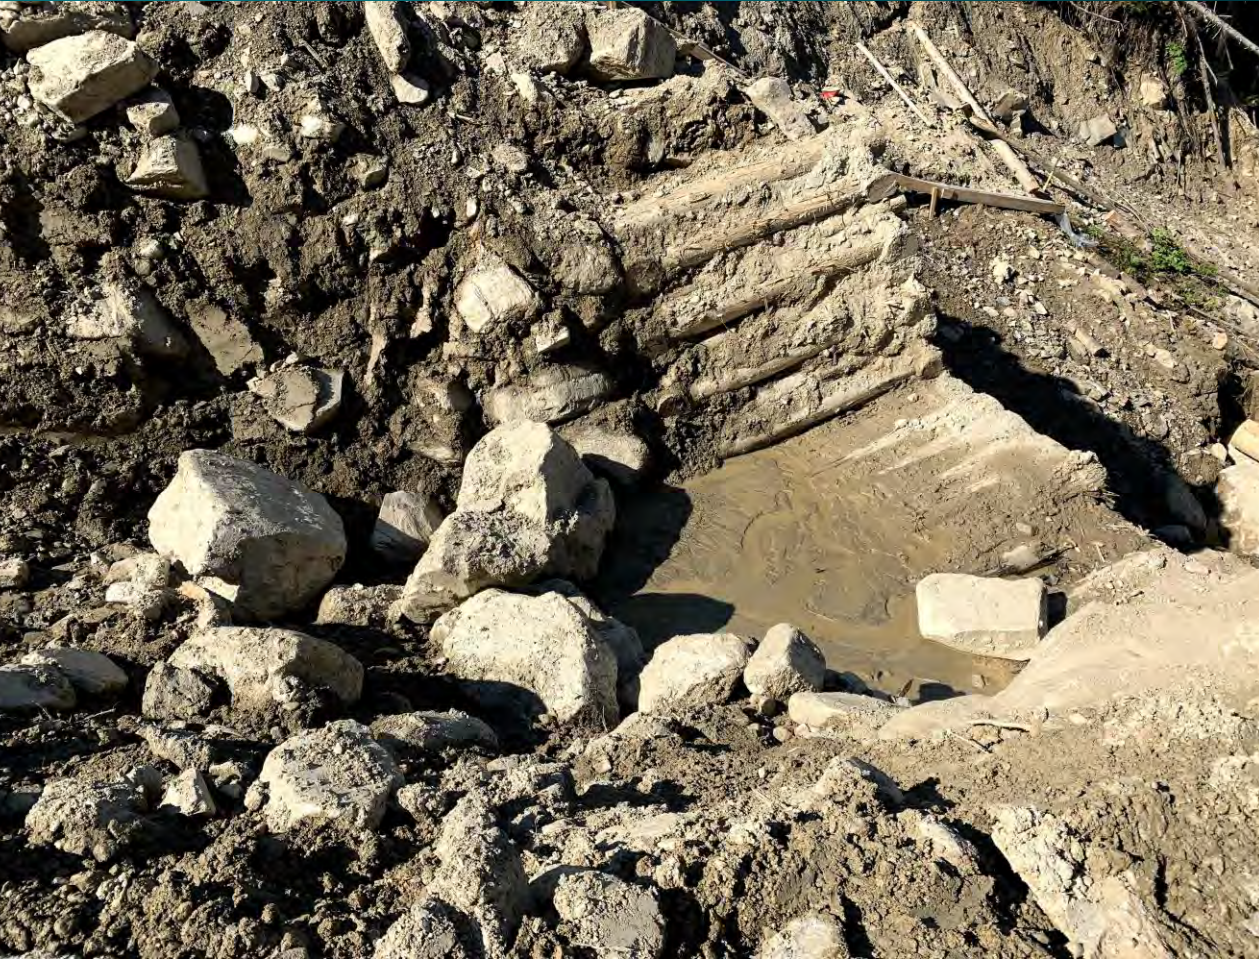
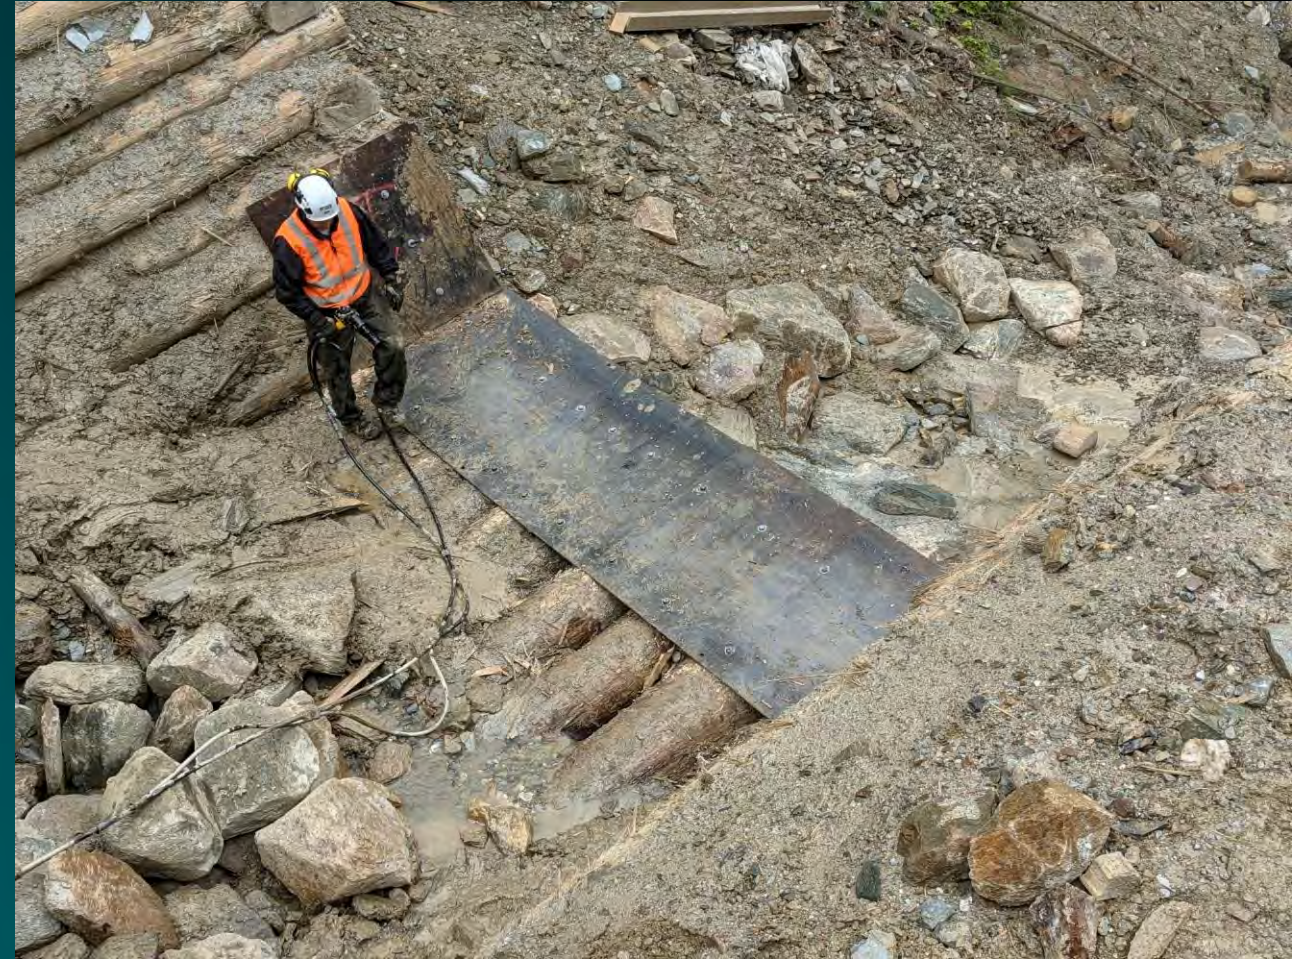
Corduroy Abrasion

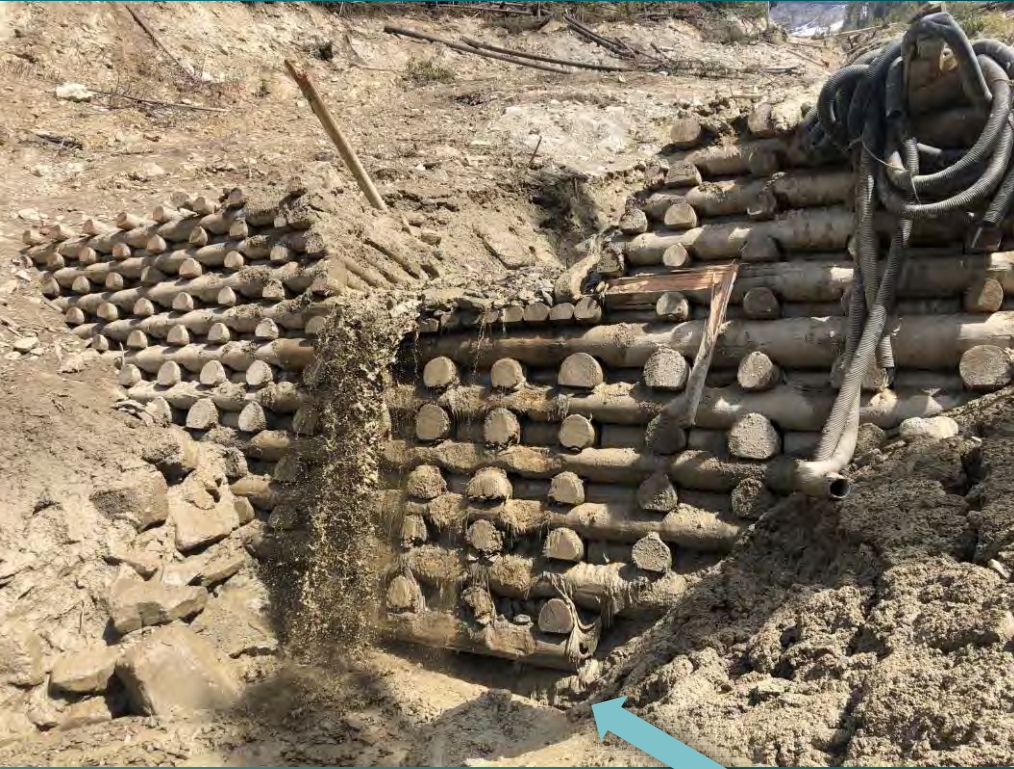
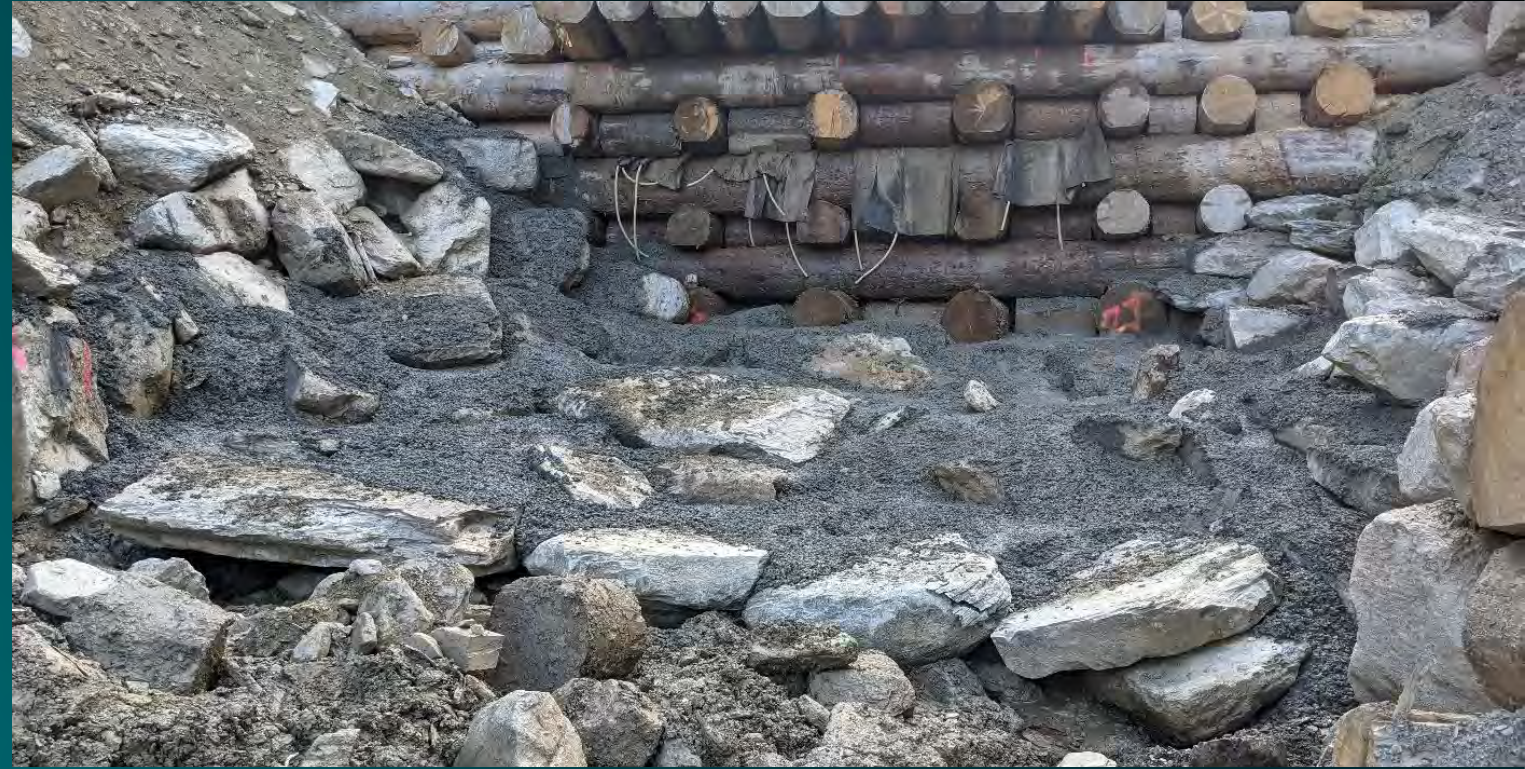
Scour and Riprap Displacement

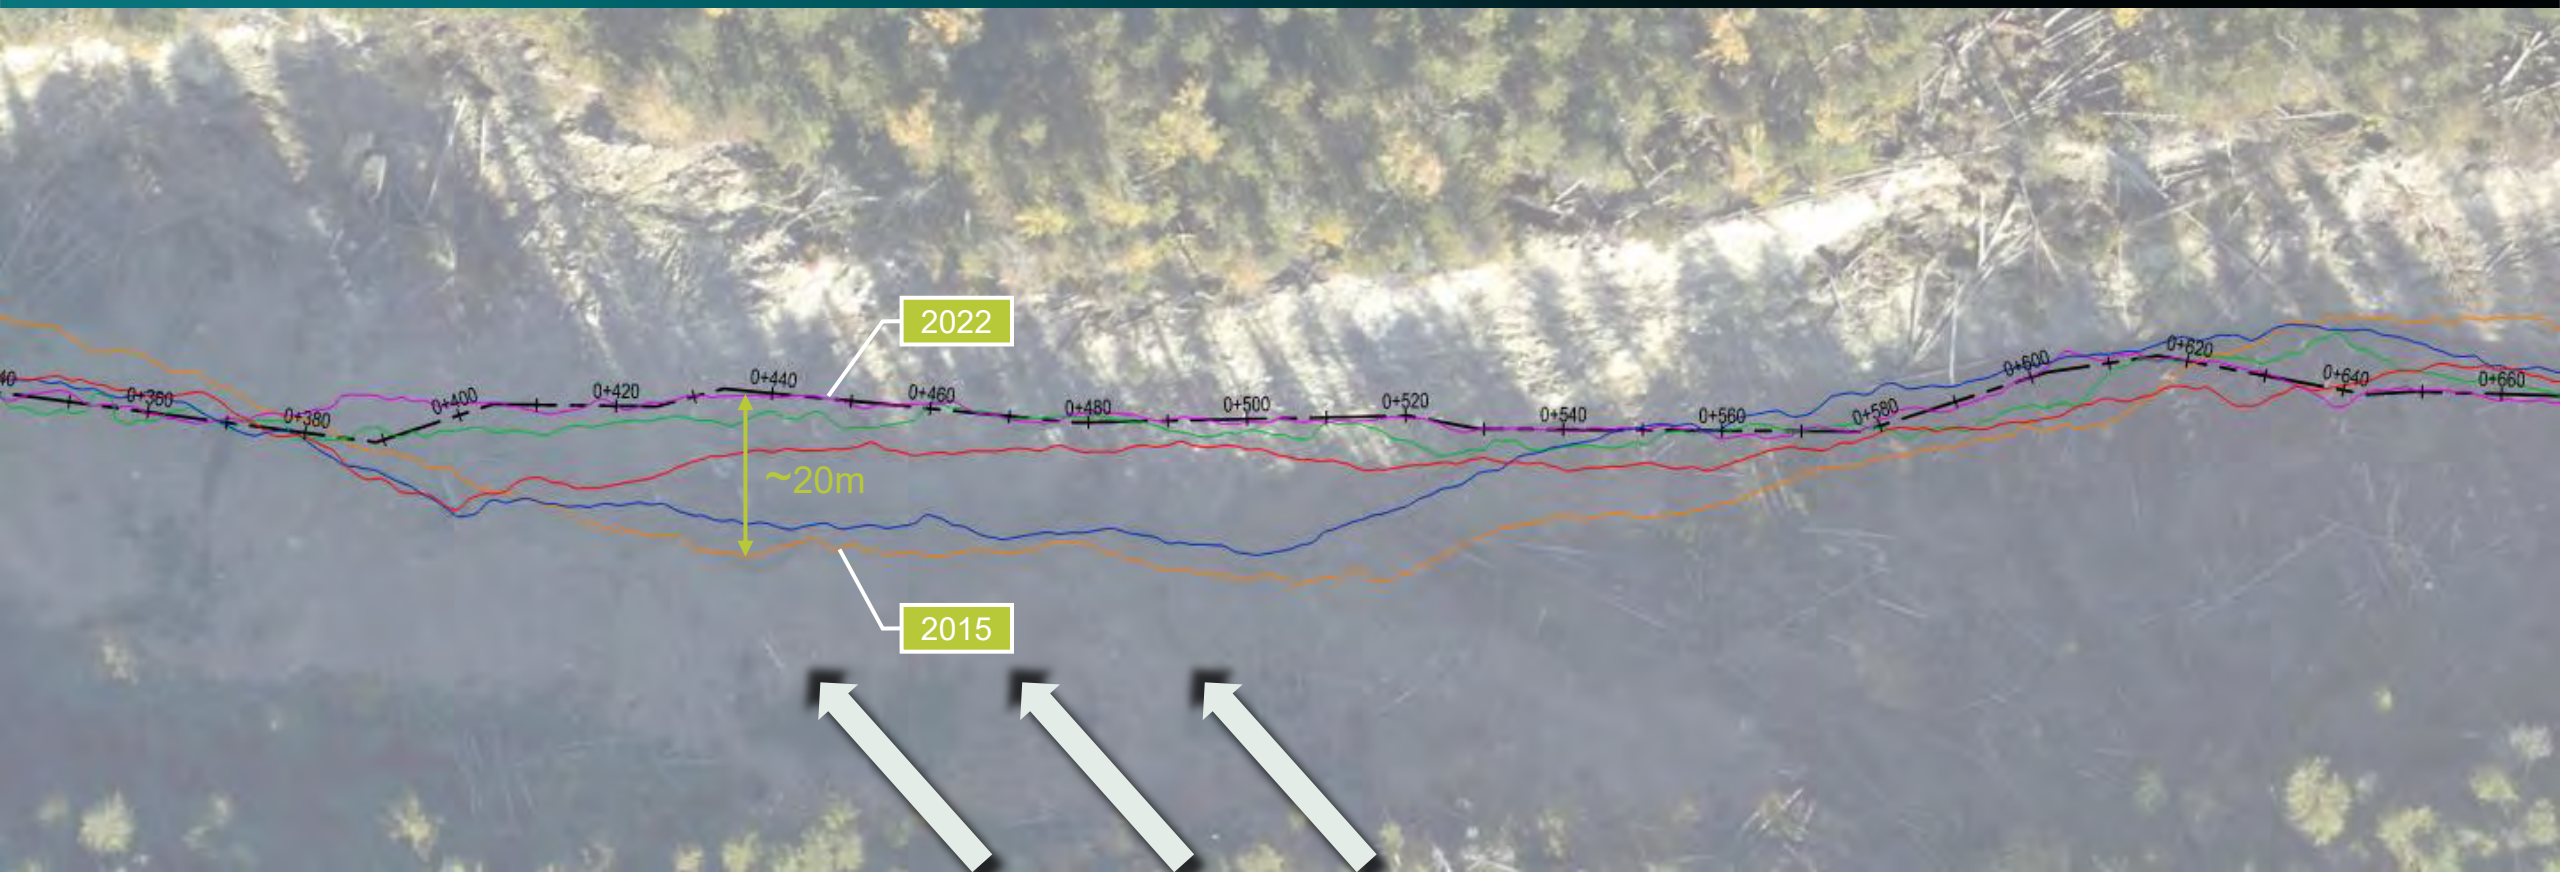
Lateral Landslide

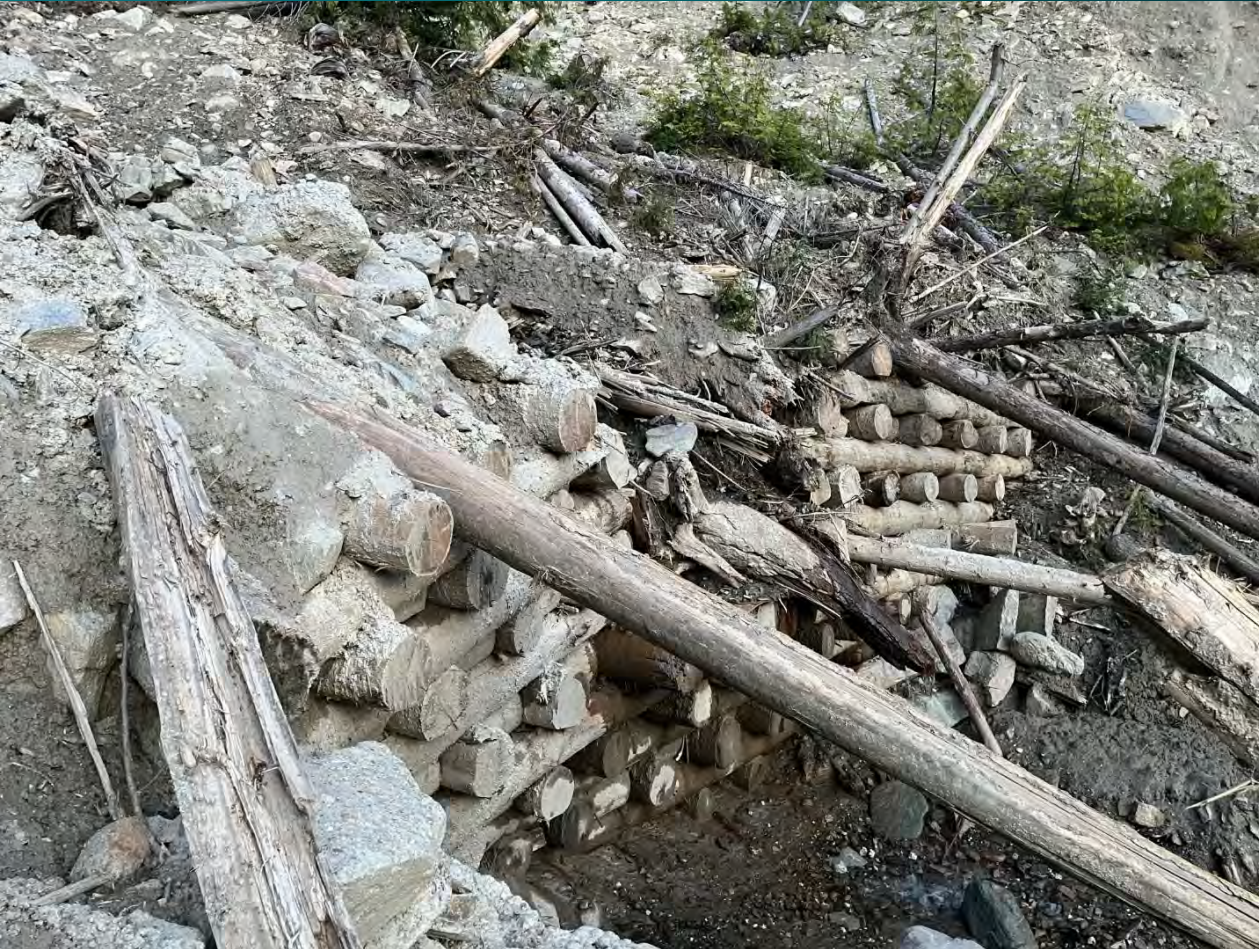
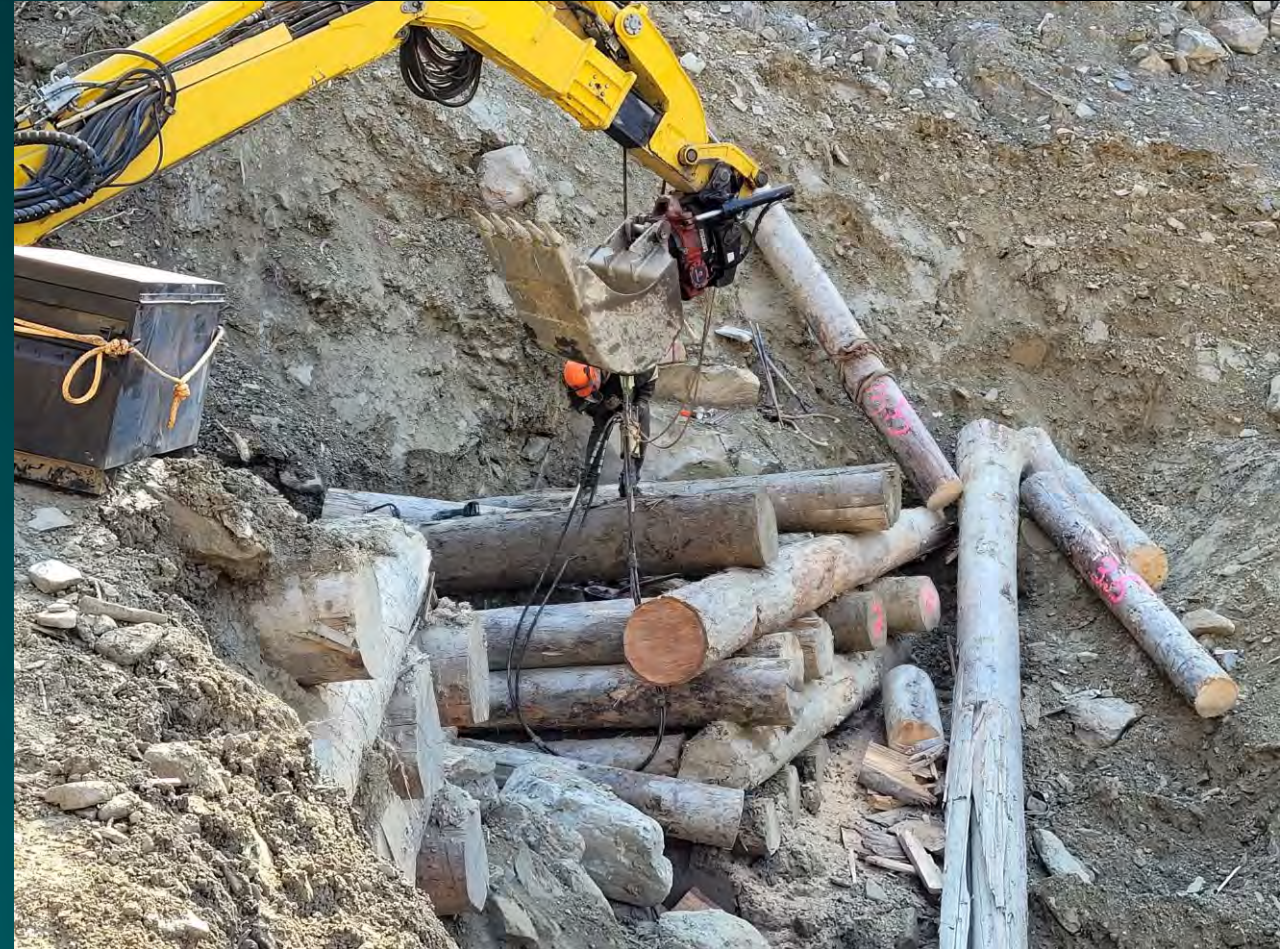
Check Dam Repairs

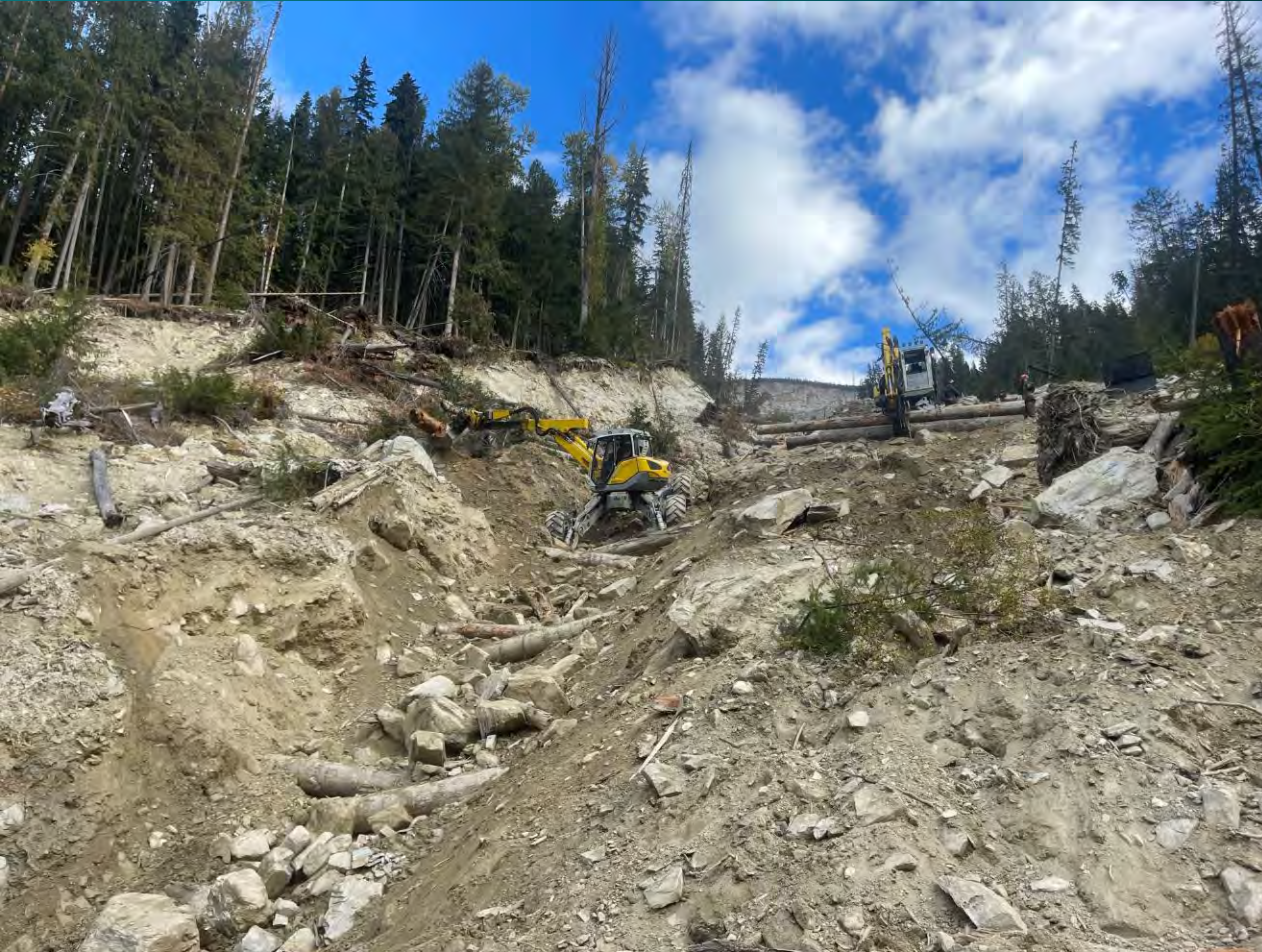
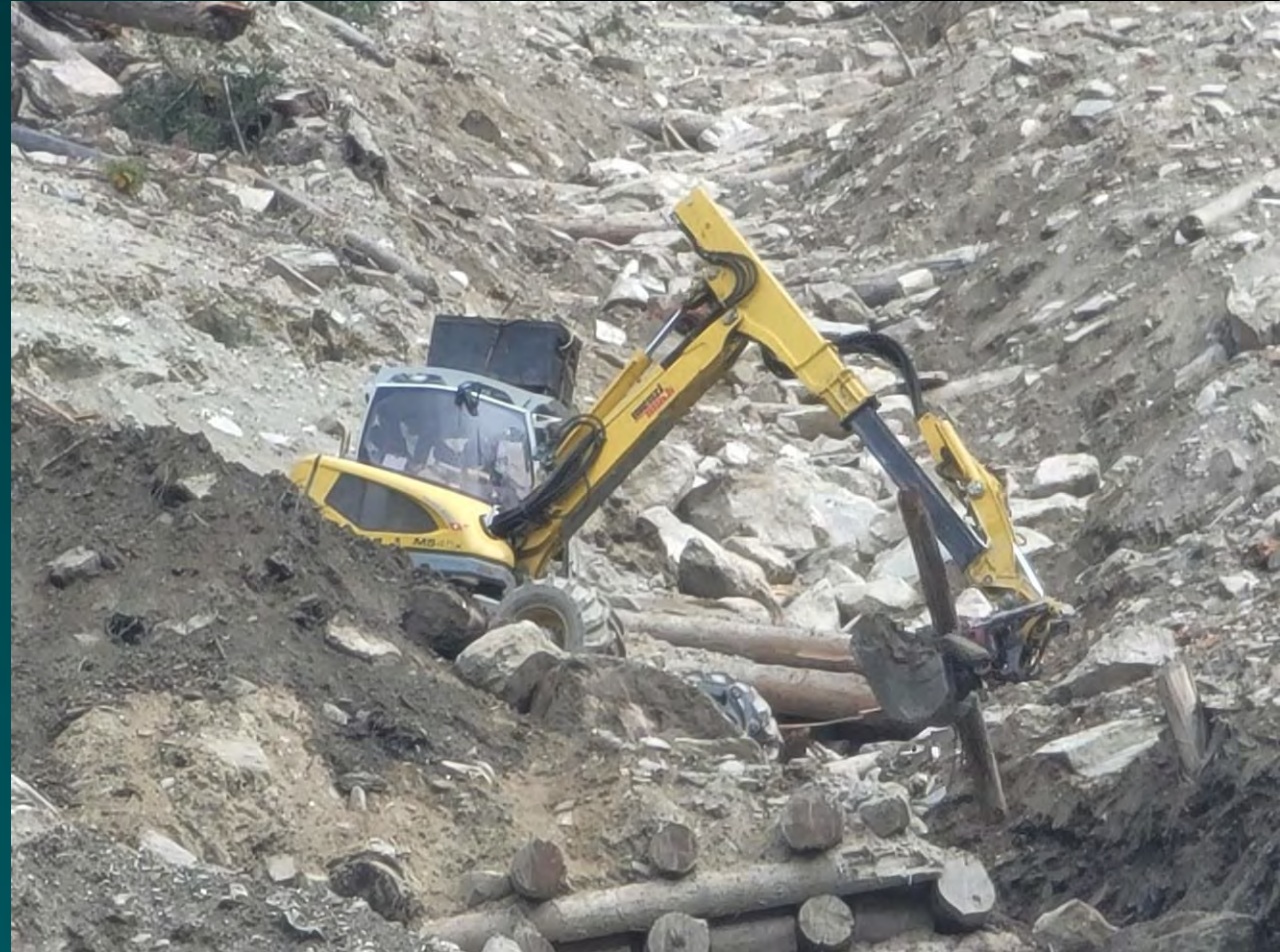
Thalweg Stabilization
