Duggan Bridge Replacement and Slope Restoration

Kristen Andersen, P.Biol., PWS, CPESC
Tara Alexander, M.Sc., P.Eng.
February 28, 2023

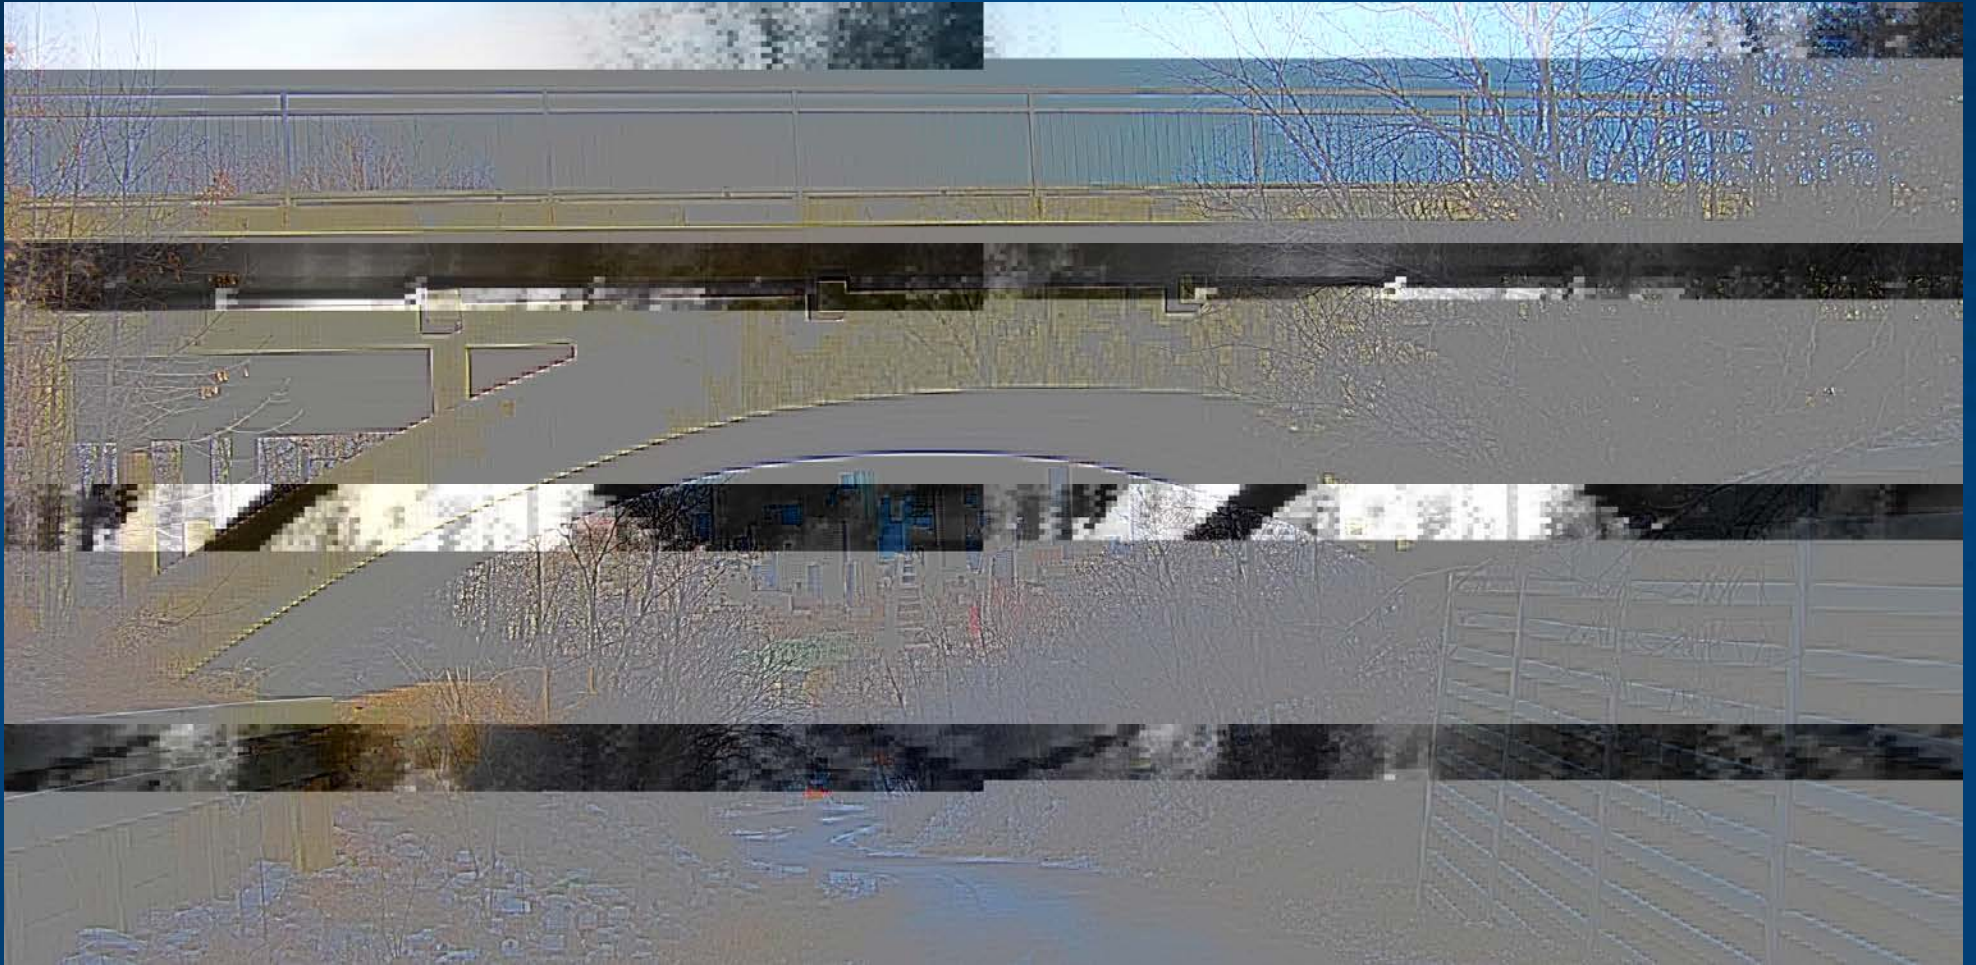
1958 – Concrete Spandrel Arch

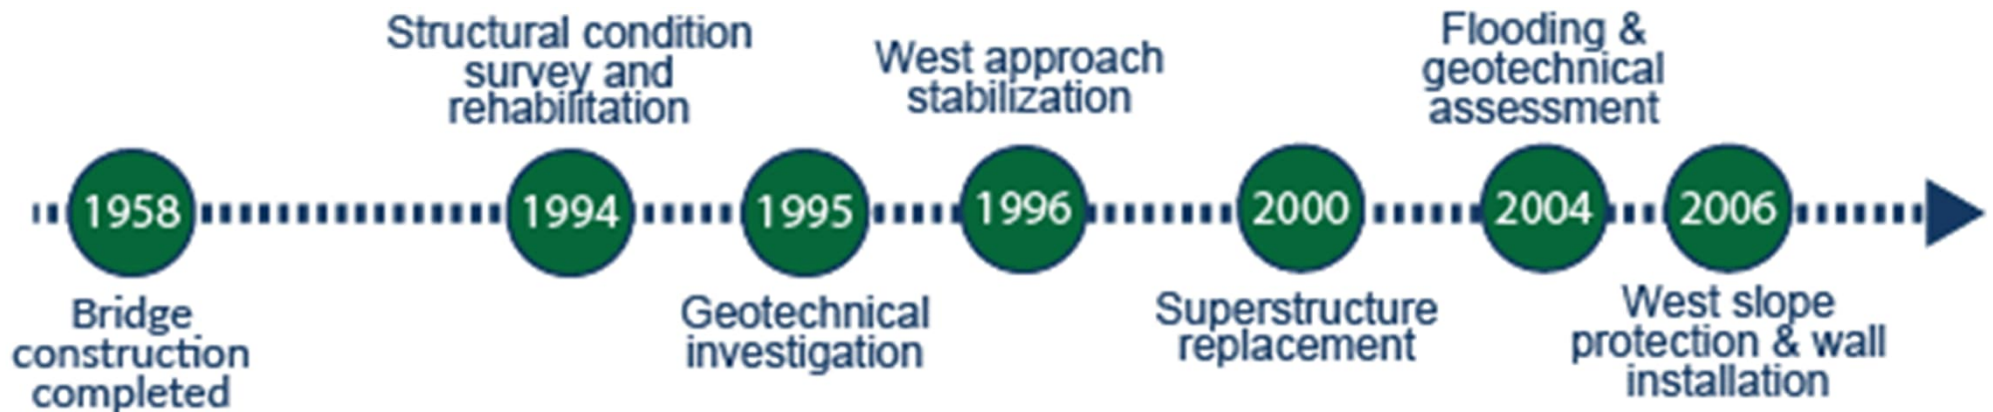
- Repeated Repairs and Rehabilitations
- Drainage – low point in road above west abutment with 0.5% slope
 - erosion behind the west abutment
 - flooding of the bridge deck

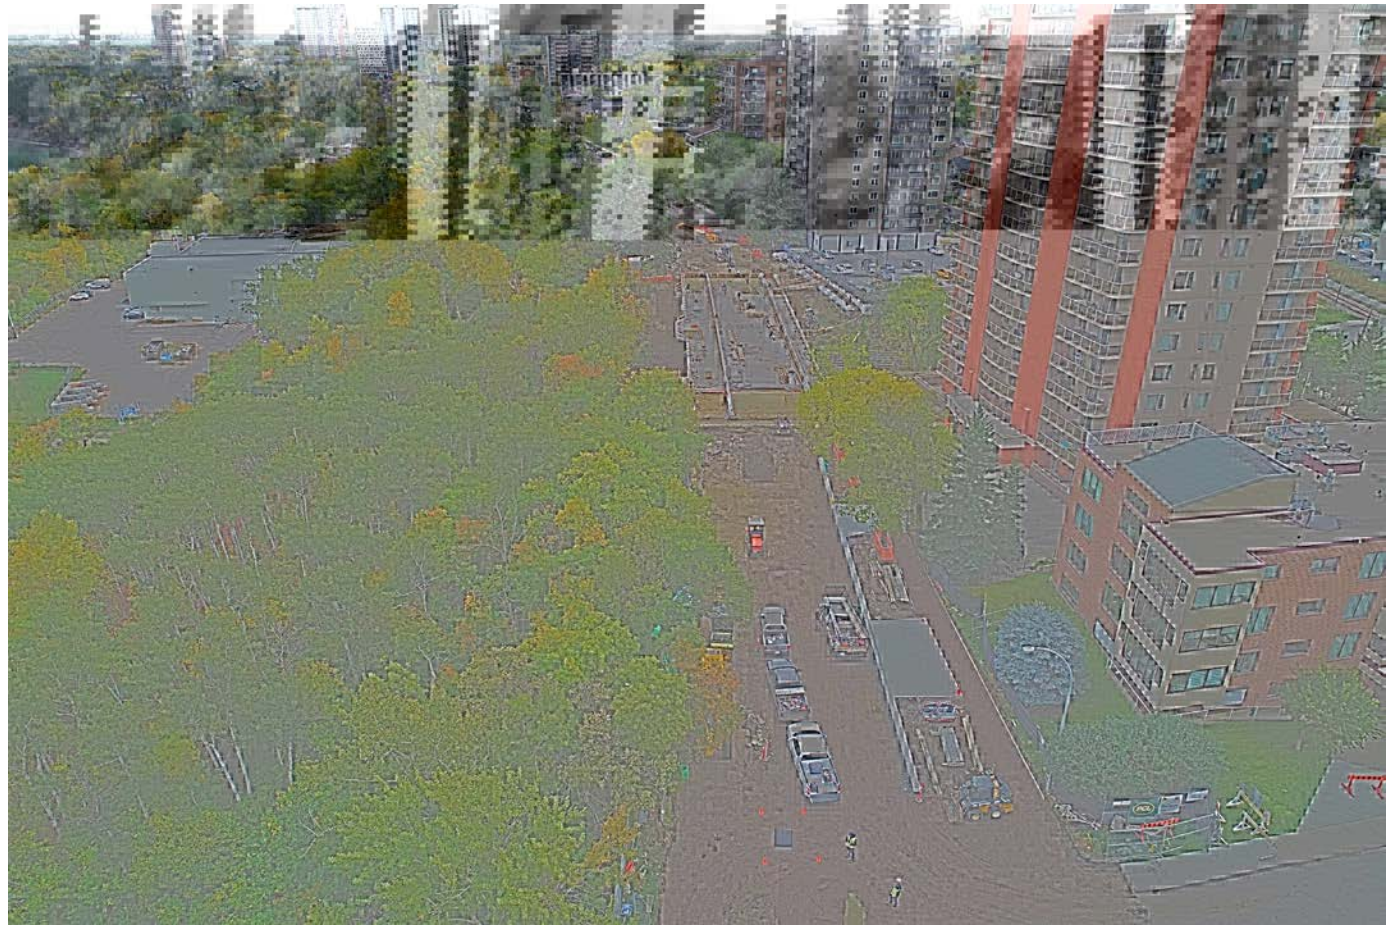
Ponding / Flooding at the west bridge abutment

Roadway Renewal of Saskatchewan Drive from 106 to 107 Street and Upgrade CBs & leads

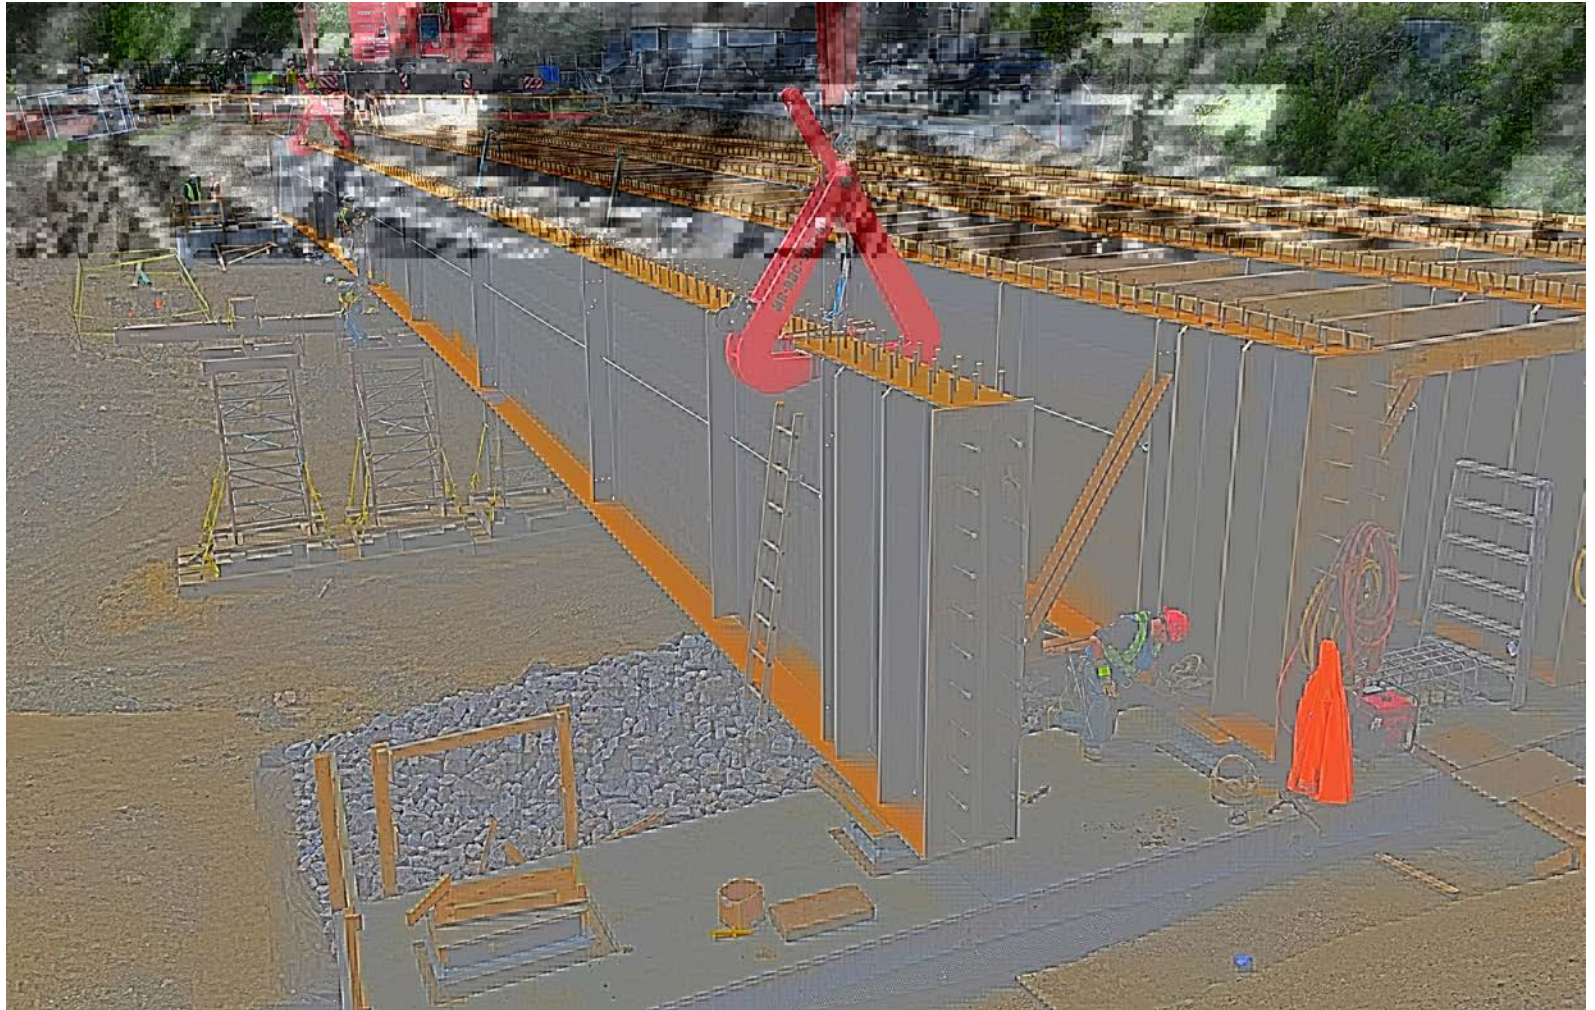
48 m clear span bridge

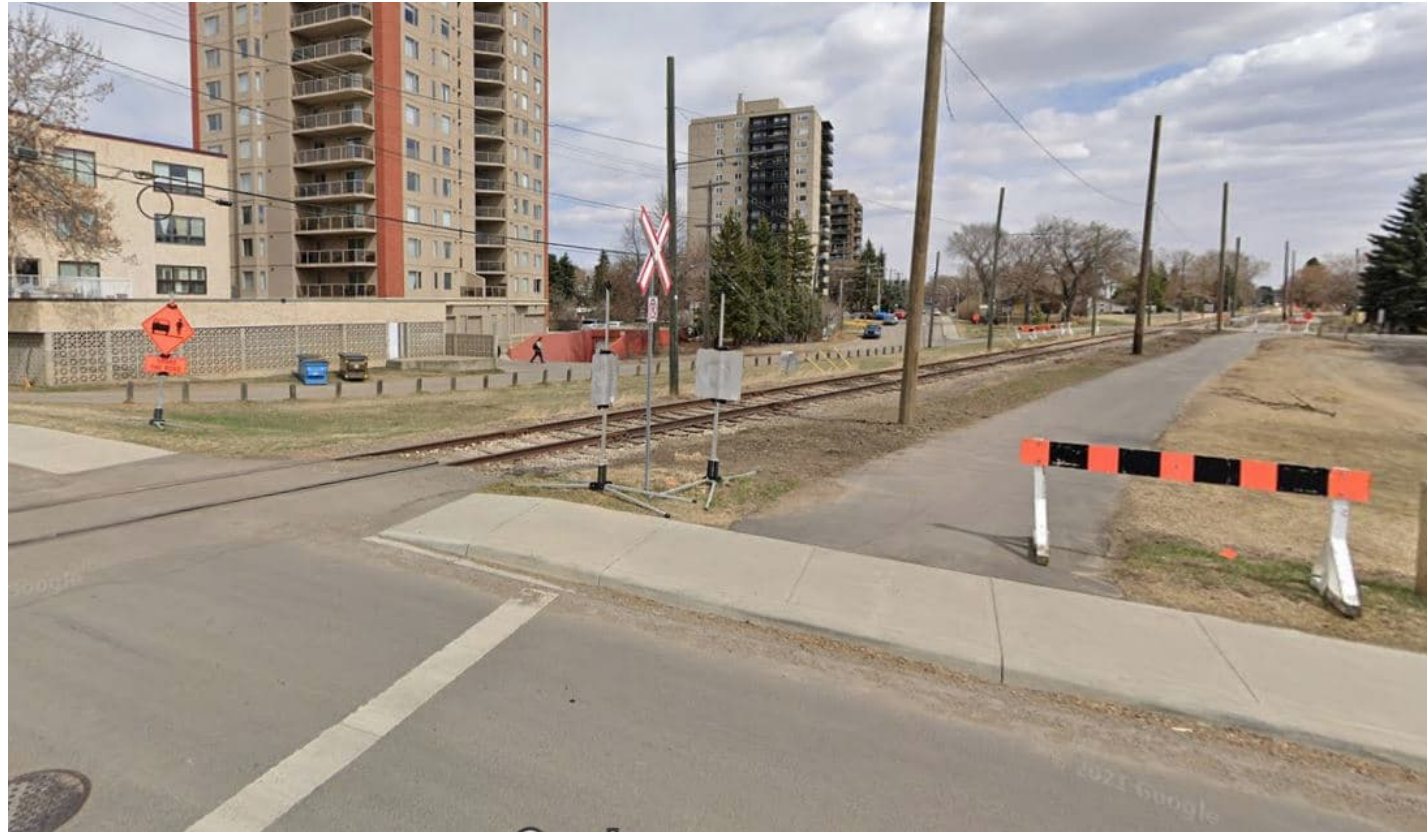
- Detour on existing routes too long

- Build new permanent SUP

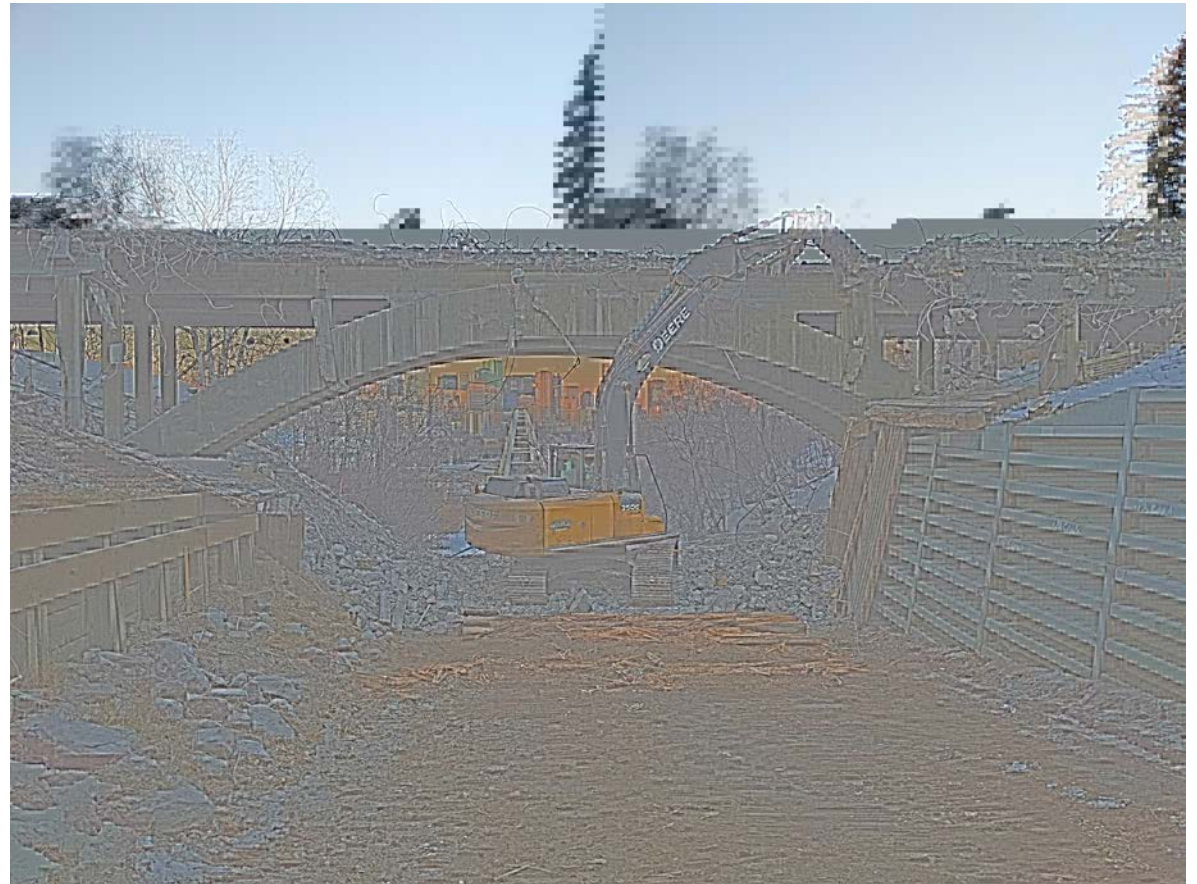
- Risk of impact to buildings because of construction activities.

- Building assessments
- Vibration monitoring

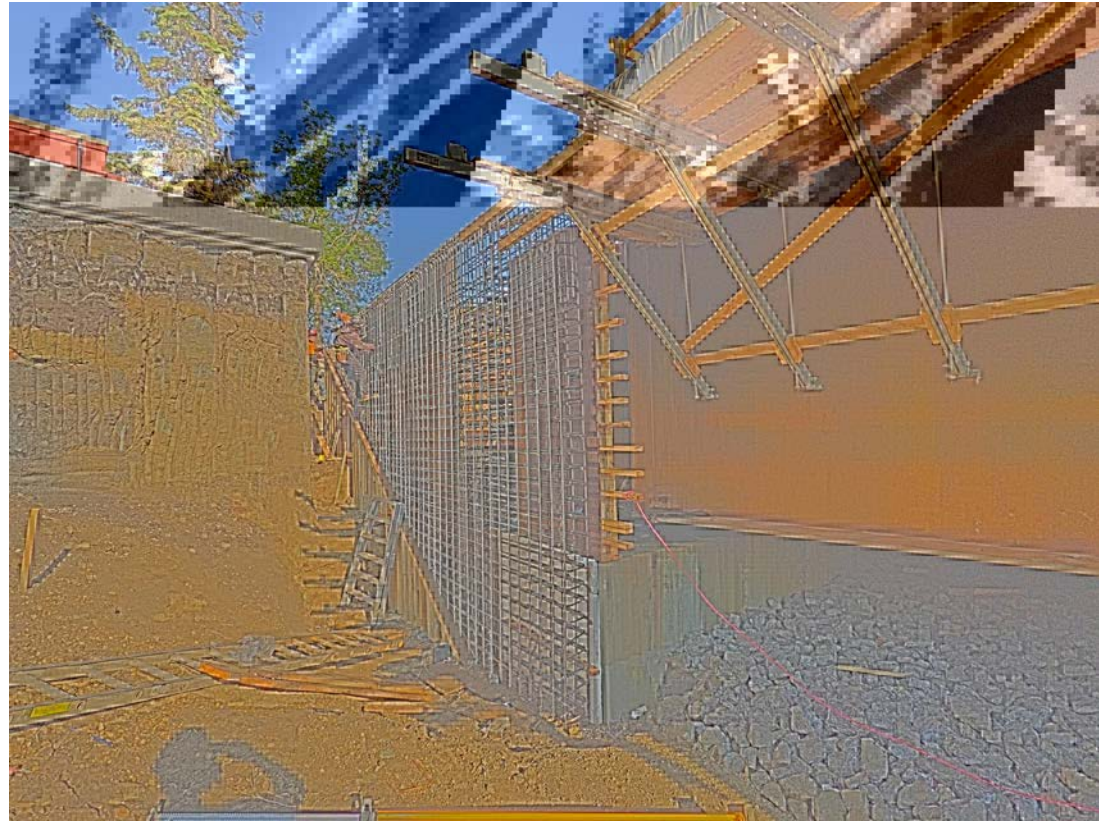
- Construction area directly adjacent to building foundations

- Construct retaining walls before slope excavation:
 - protect the building foundations
 - allows steep slopes to be excavated to install the bridge abutments

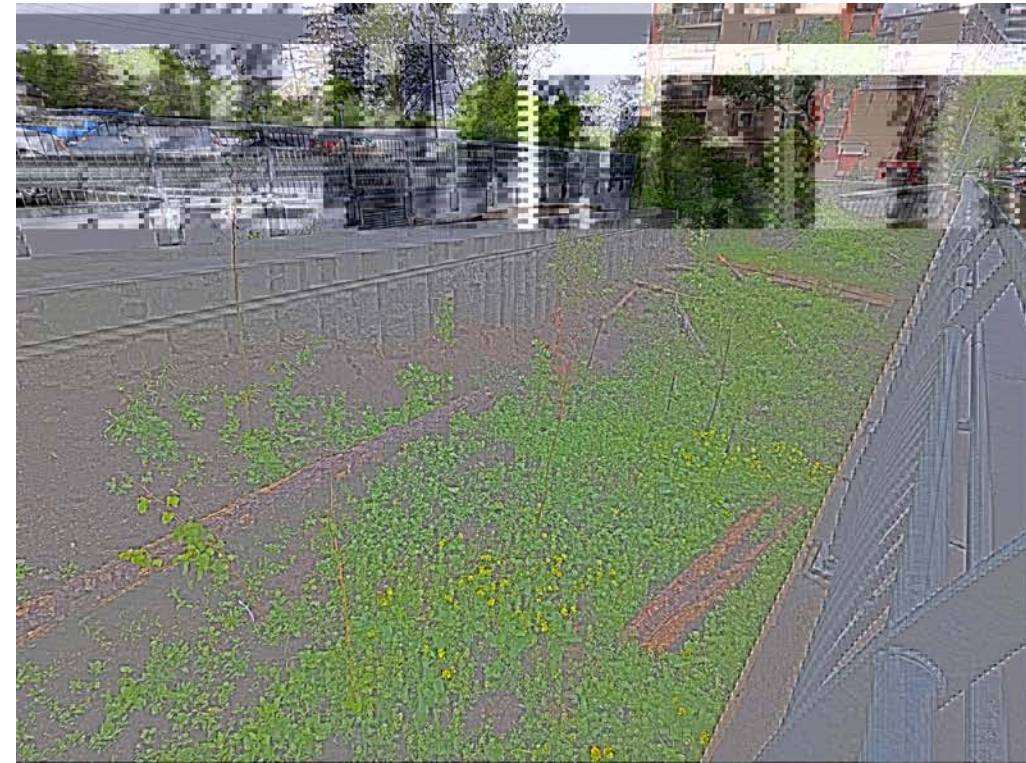
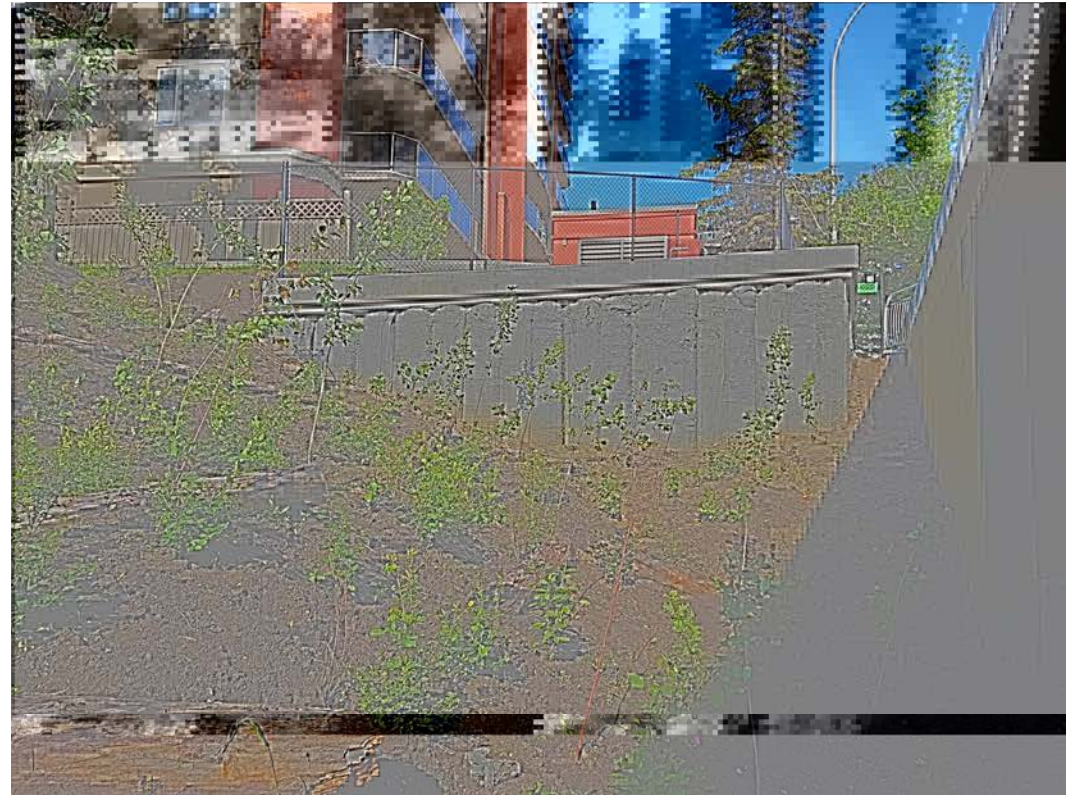
- Steep slope and erosion
- Native forest establishment

- Soil bioengineering
 - Rough & loose soils
 - Large woody debris
 - Live staking
- Topsoil salvage and replacement
 - Native species propagules

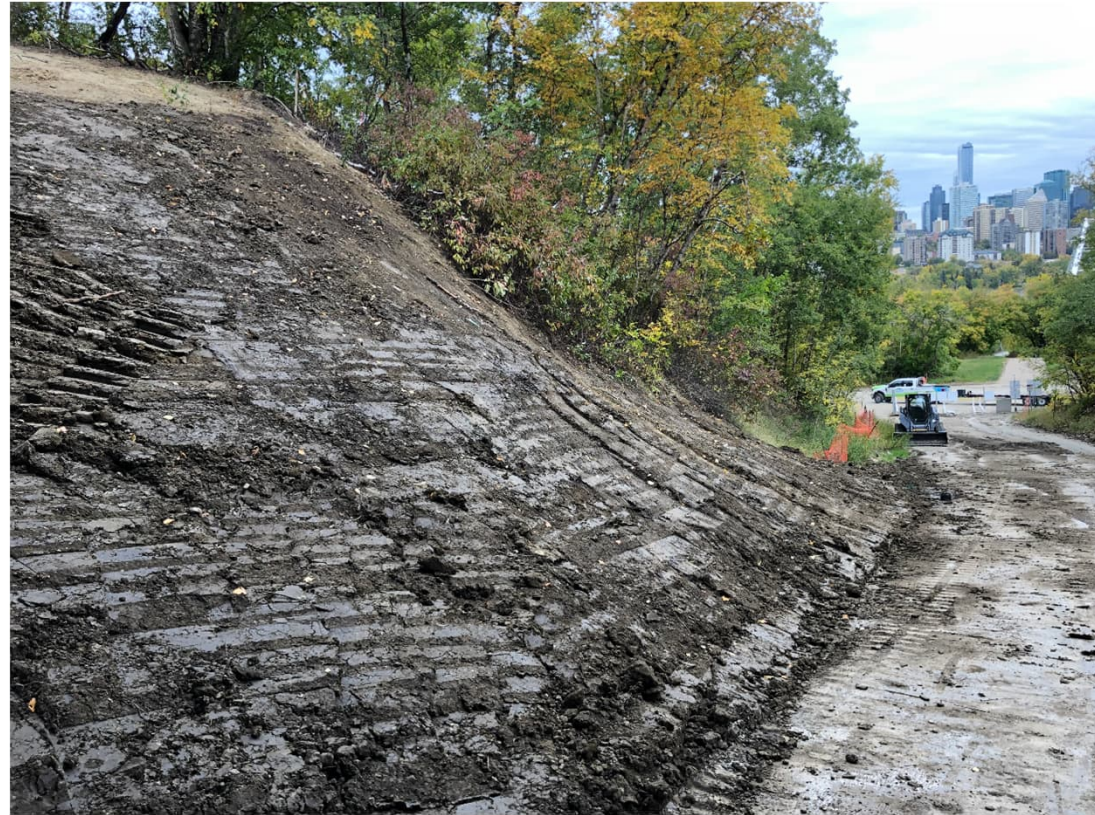
Rough and loose soil – erosion control, microsities

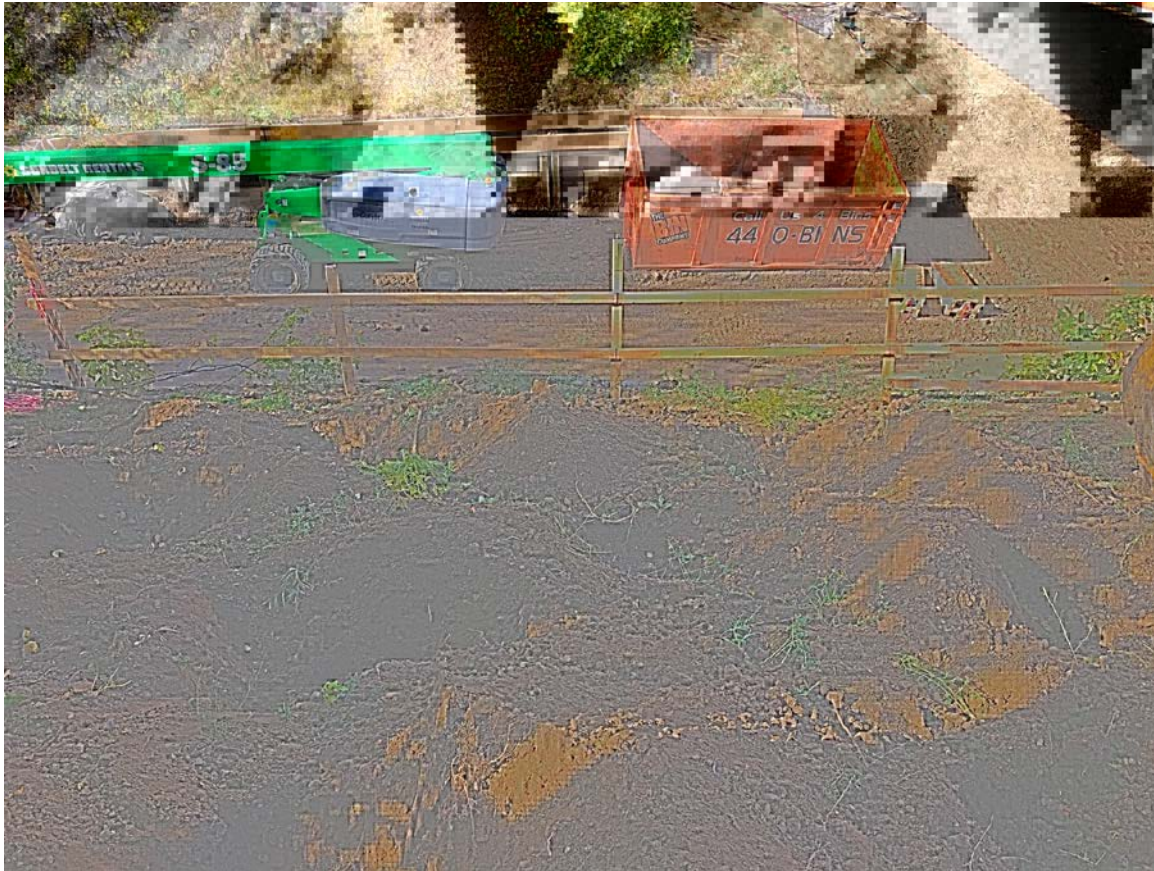
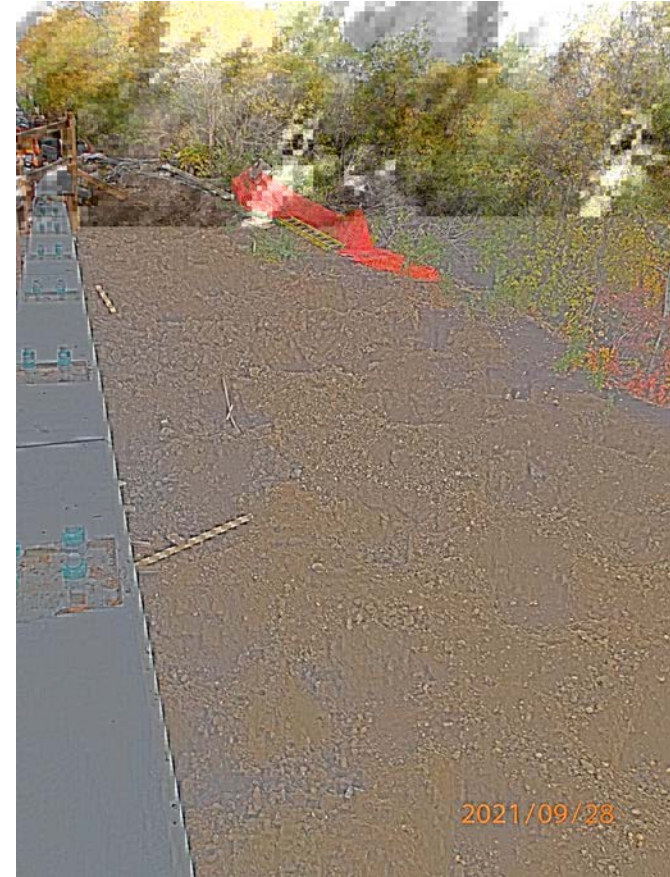
Live staking - root depth and canopy closure

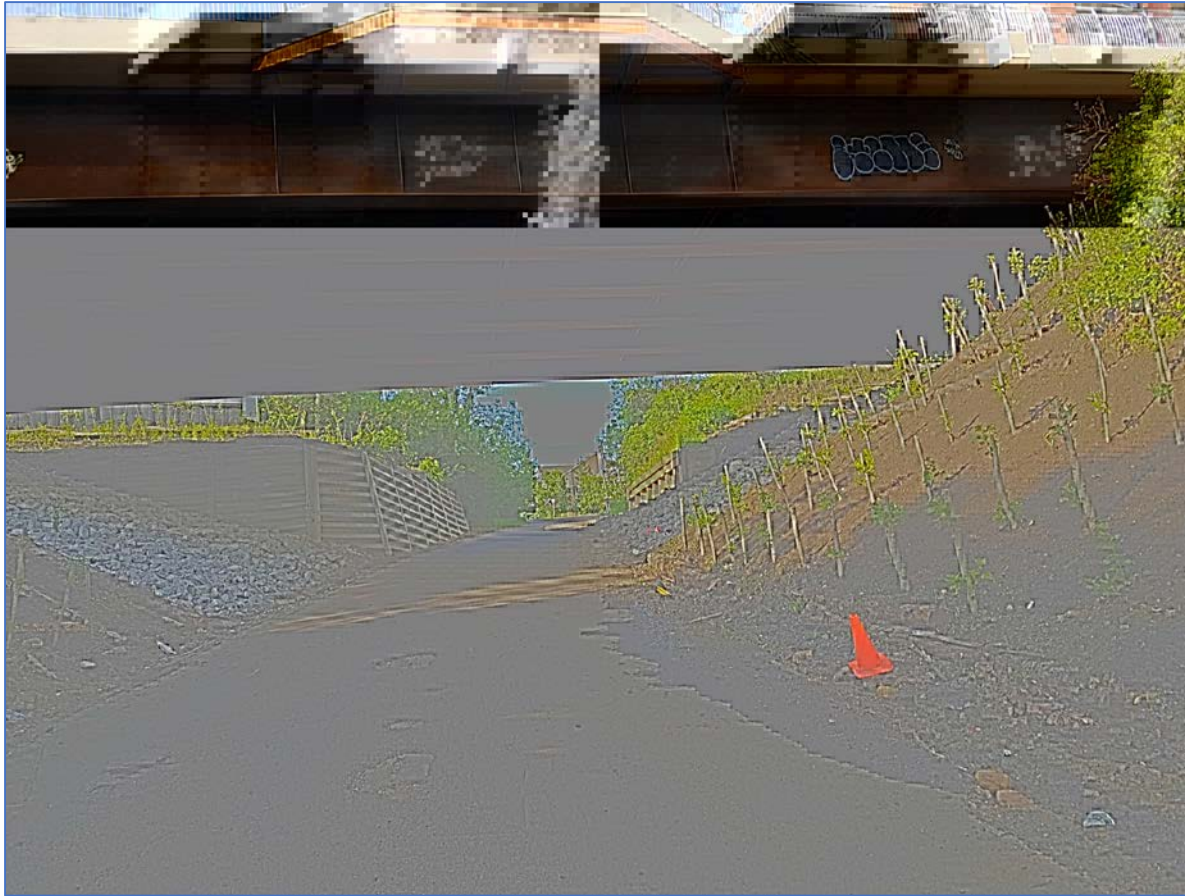
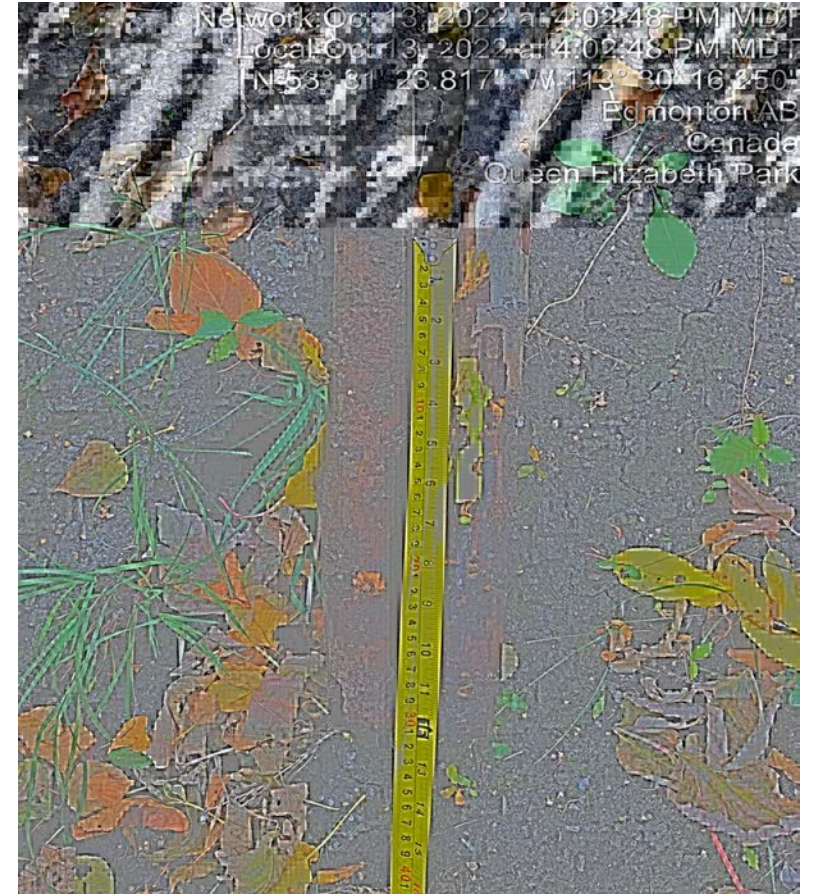
Large woody debris – microsites and soil quality

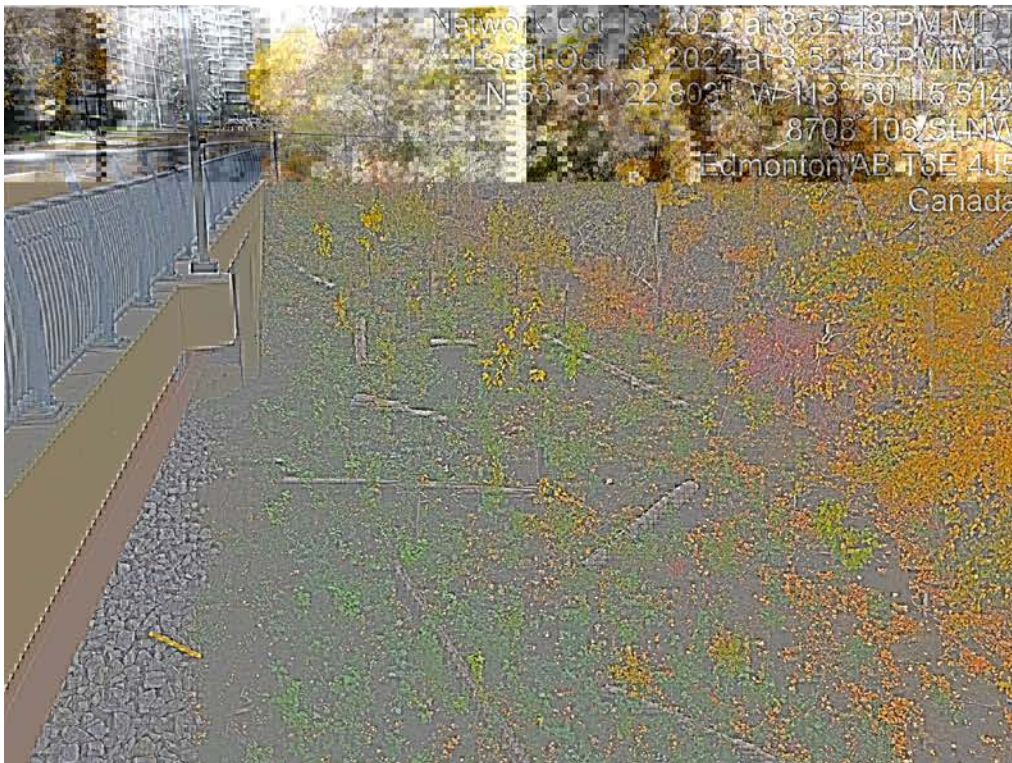
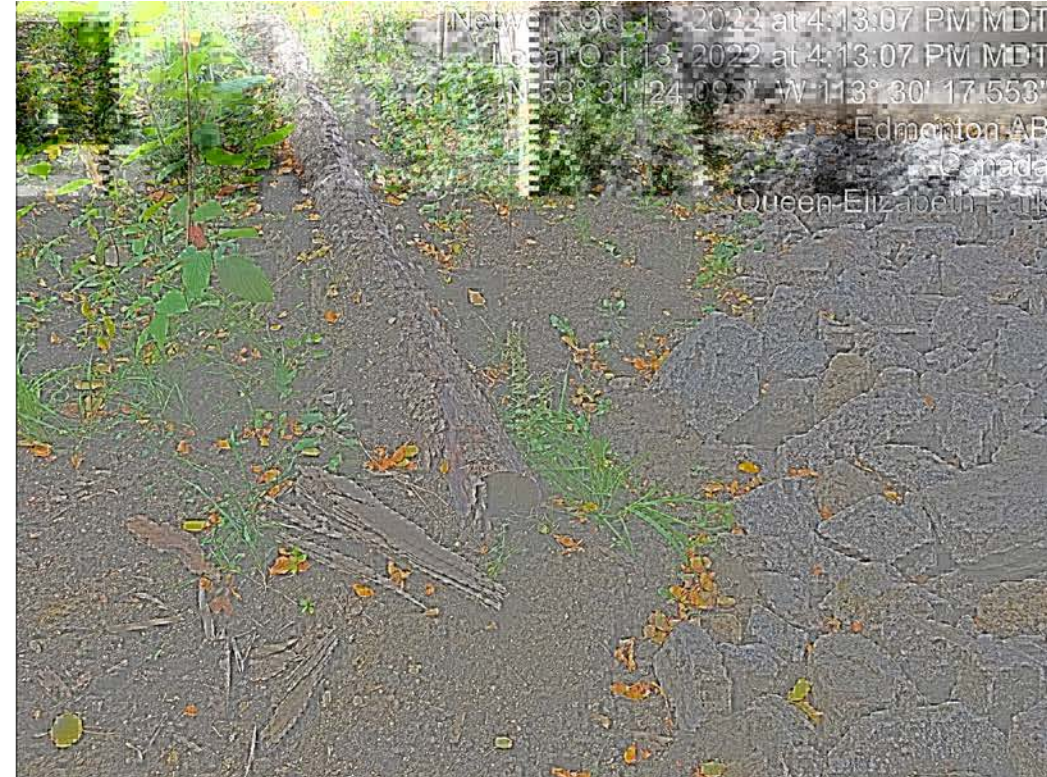
Topsoil salvage/replacement versus dig and dump

- Weed seed in imported soil

- Avoid dig and dump, replace salvaged soil
- Canopy closure
