Nose Creek Re-Alignment

Working with Multi-disciplines and Regulators to Improve Transportation Impacts/Interfacing with Natural Assets

Scott Etzel, P.Eng., PMP

February 27, 2023

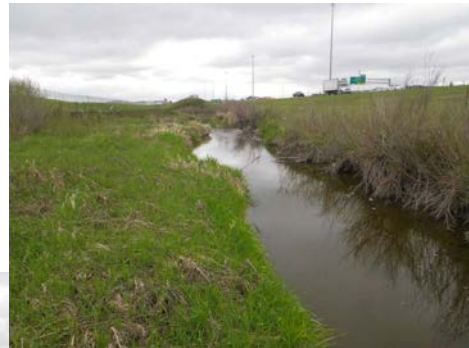
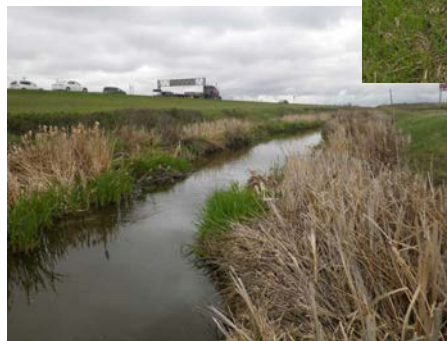
Project Onsite Environment Concern

As seen previously, the Creek was the SB drainage ditch for Highway 2

Runoff from the highway and no control or mitigation measures should spill occur

Prevalence of weeds and non-native grasses
 Reducing ecological Resilience

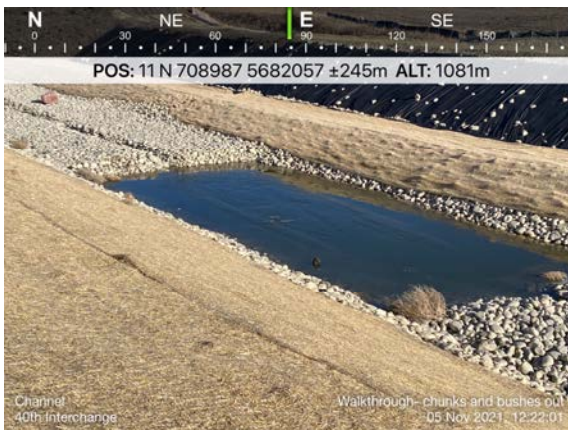
Pool – main habitat feature

AKA Fish hotels

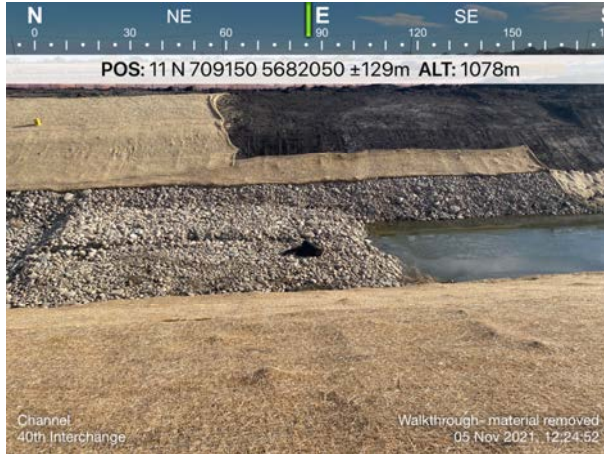
Riffle – Focus flow to the centre AKA Speed bump

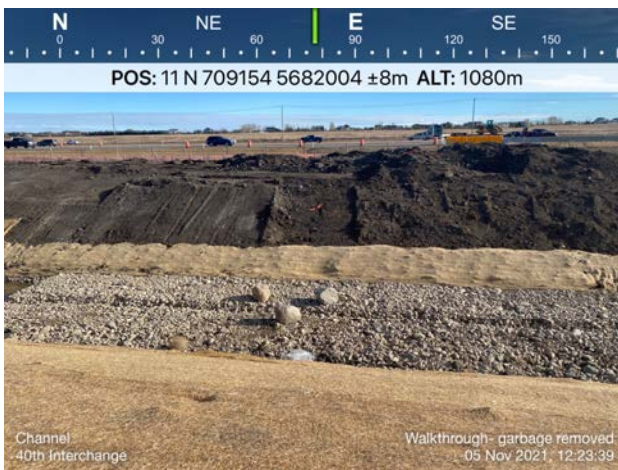
TYPICAL BOULDER CLUSTER DETAIL

Boulder Clusters – Shade and slow flow area

AKA Rest Stop – or bird perch!

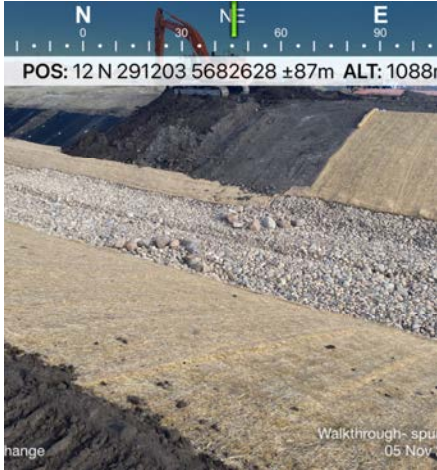
Spurs (Opposing Wing Deflectors) – Shade and slow flow area

AKA Flipper... pin ball anyone?

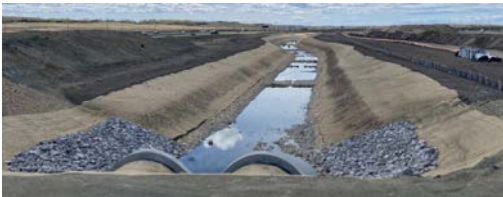
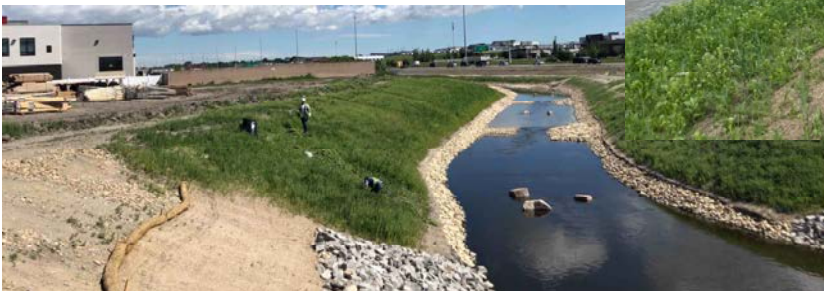
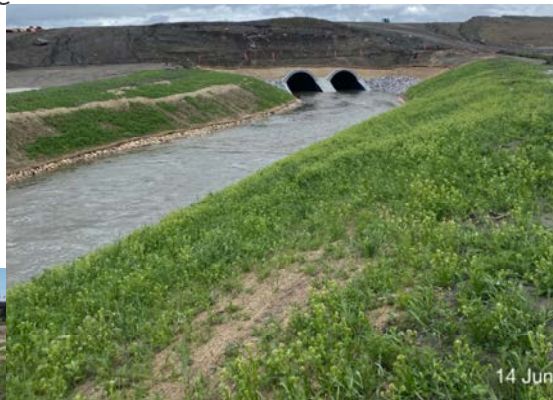
Revegetation – Willow and Natural Riparian seed mixes

Shade, bank stabilization, food – Aquatic Life

Habitat, Cover, food – Wildlife

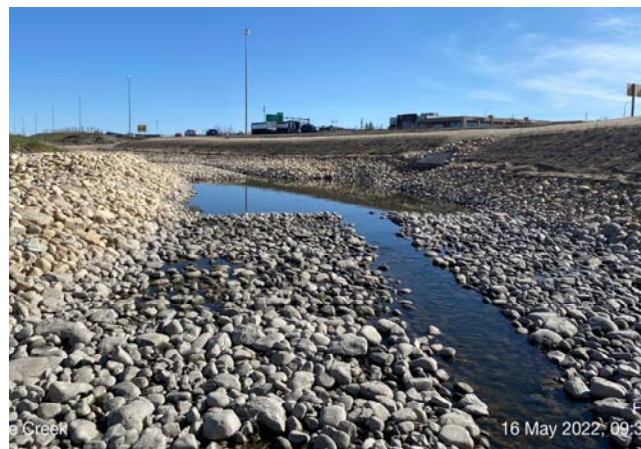
- Length of Channel: 1,004m long
- Volume of Excavation and Rock: 97,051 cubic meters of dirt and rock excavated
- Length of the culverts: 251.2m of culvert constructed (Twin - 125.6m length of channel)
- Area of fabric: 46,040 square meters of geotextile
- Number of Willows planted: 33,000 willows planted

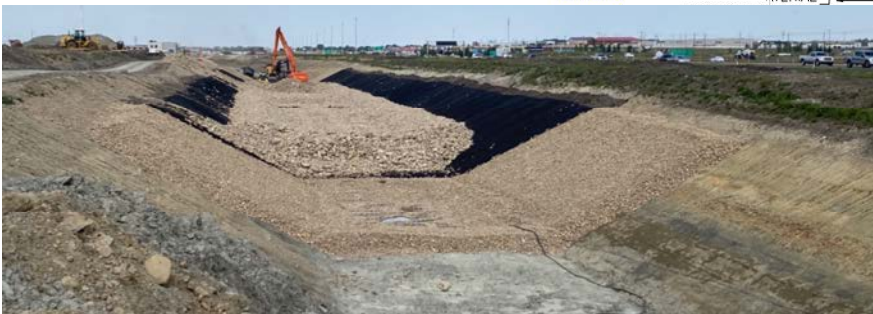
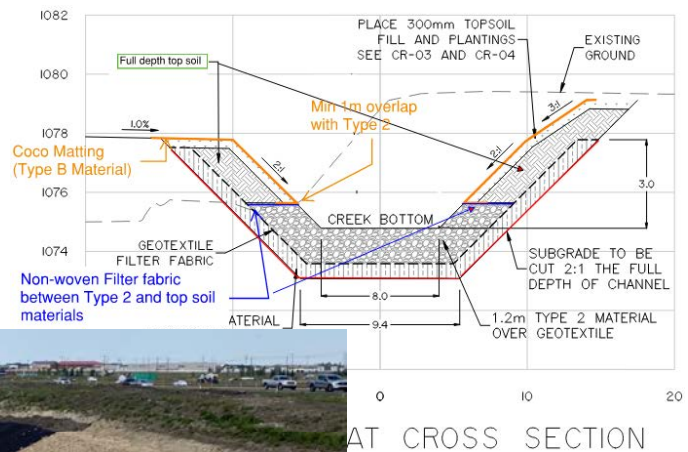
Improvement 1 Cross Section

Multiple Disciplines involved (Multiple consultants) through Regulators

Additional fabric added and depth of topsoil increased

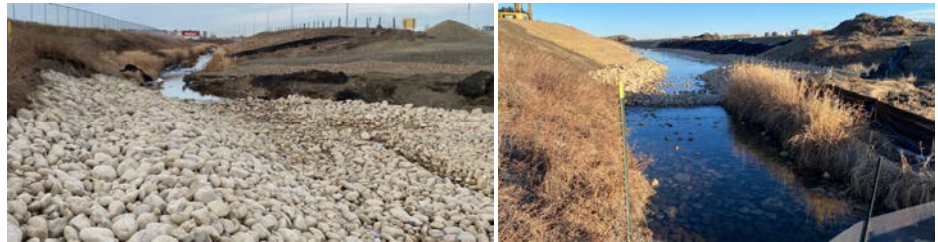
Improvement 2

Tie-in Location and Temporary diversion channel

Focused more on natural transition to the new cross section from the old

Minimized impact and disturbance

Public Safety (Adjacent On-ramp and Storm Pond with Pathway)

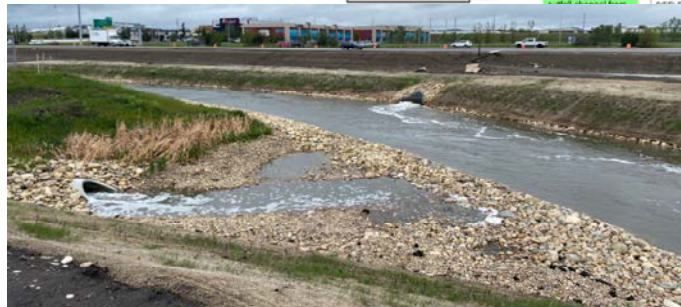
Improvement 3

Sierra Springs Storm Pond Outfall

Improve tie in and saved some existing riparian vegetation.

Additional sedimentation area and permanent ESC along bank

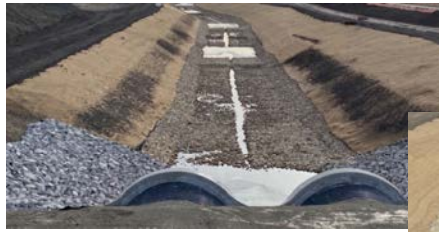
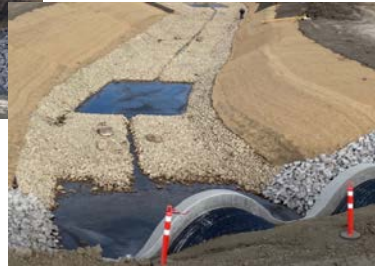
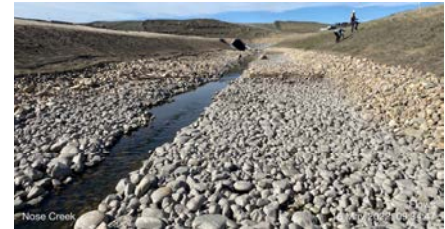
Improvement 4 - Addition of V-notch

Critical - Fish Connectivity!

Days after opening

May 2022
